The Largest WWTP In Europe Repairs & Reinforces Its Main Outfall Pipe With METALCLAD DurAlloy & DuraWrap

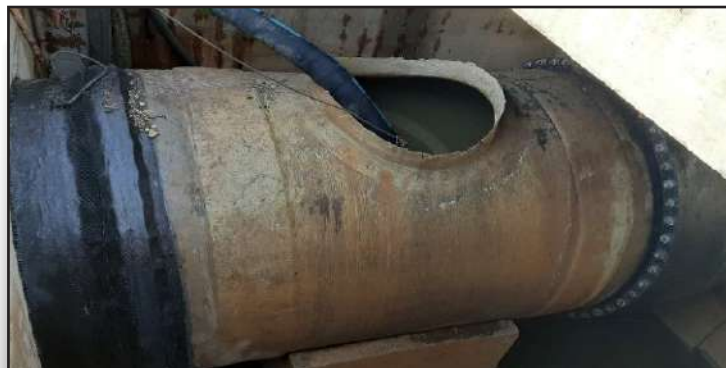
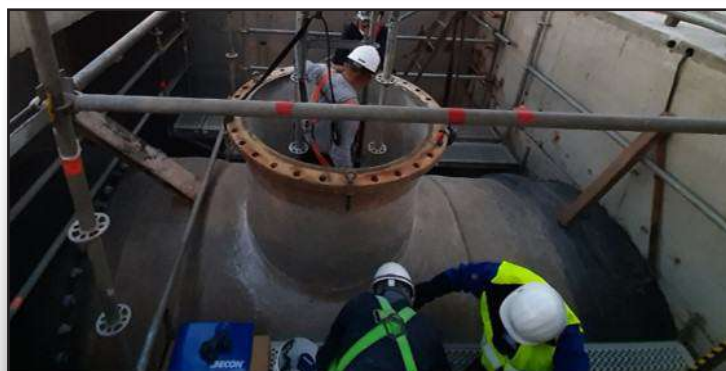
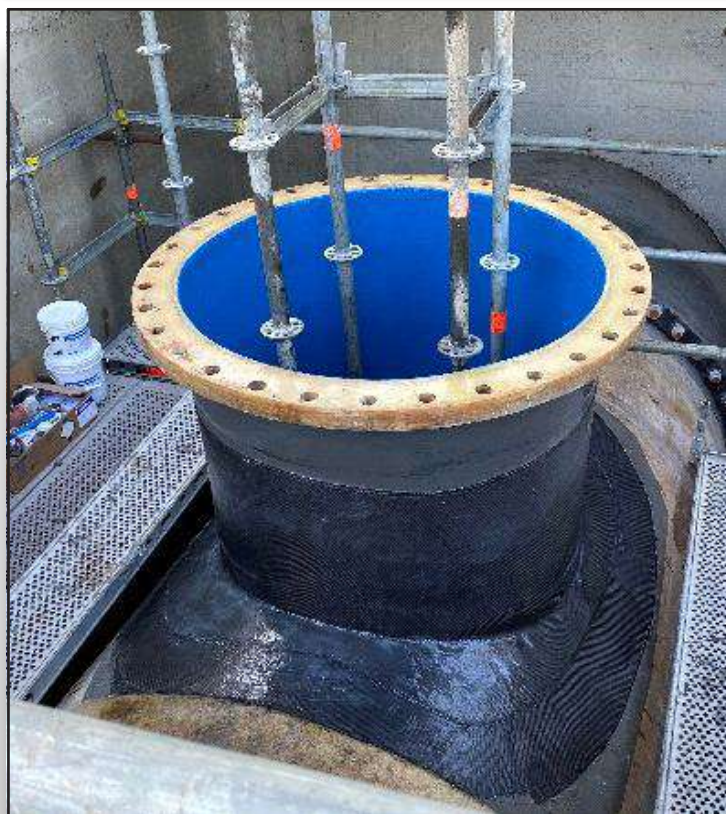
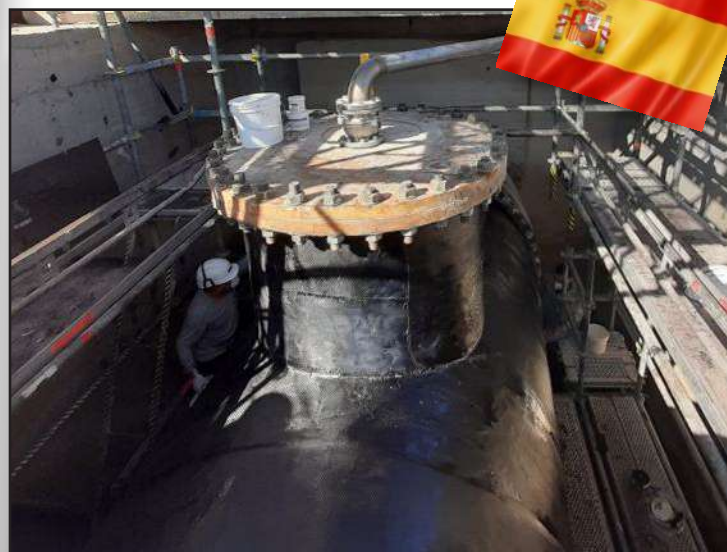
After the successful structural reinforcement of the two ends of the outfall of a wastewater treatment plant (WWTP) in Spain, which had lost much of its thickness due to corrosion in a steel section as well as cracks in the GRP section (glass fiber reinforced plastic), the WWTP called the ENECON distributor in Spain (PROENECON) because of an unexpected break of the pipe's neck. This was the 47 inch diameter GRP junction with the main 83 inch GRP pipe.

This repair was much more complicated than the previous one since, in this case, it was a total break causing a flood. The water

level could not be lowered more than $\frac{3}{4}$ of an inch below the area of the break. After divers retrieved the junction from the bottom of the water-filled manhole, the PROENECON technicians proceeded to glue it to the main pipe using METALCLAD DurAlloy. Then they reinforced the joint both on the inside as well as the outside with DuraWrap.

DuraWrap provides structural reinforcement for pressure pipes, meeting ASME PCC2 and ISO 24817 allowing the outfall to be commissioned in just one week.
