## Packed Bed Scrubbers At Water Utility Protected With ENESEAL CR

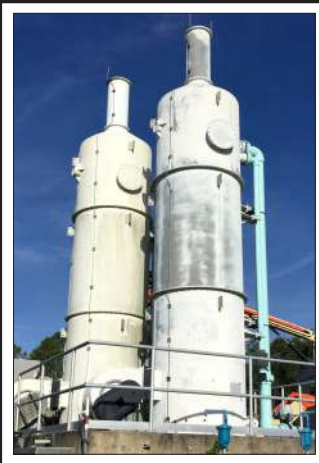
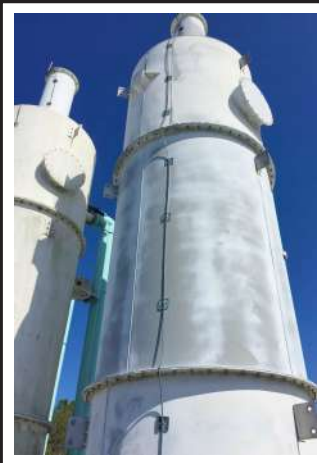
*Before*

Two of these tanks are made of fiberglass and the third is made of polypropylene. The original

protective coating on all three scrubbers had failed and the sun's UV rays were causing oxidation. The ENECON Field Engineering Specialist was contacted to find a solution.

ENESEAL CR was recommended because of its UV and corrosion resistance as well as its excellent adhesion properties. The adhesion properties to fiberglass were known but unknown to polypropylene. A test patch was applied to the polypropylene scrubber and after seven months continued to show excellent adhesion.

The scrubber's surface was pressure washed, manually abraded then pressure washed again. Two coats of ENESEAL CR were applied to the fiberglass scrubber and three coats to the polypropylene scrubber. *Problem Solved!*
