## CeramAlloy CBX Protects Newly Fabricated FPSO Caisson From Internal Abrasion Damage In Australia

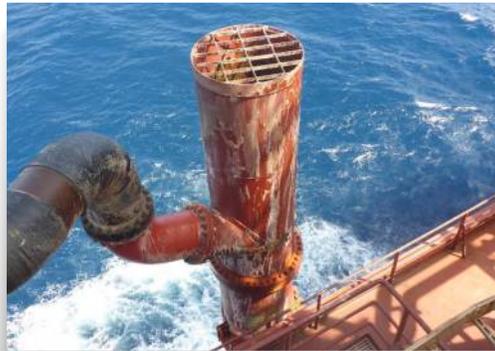
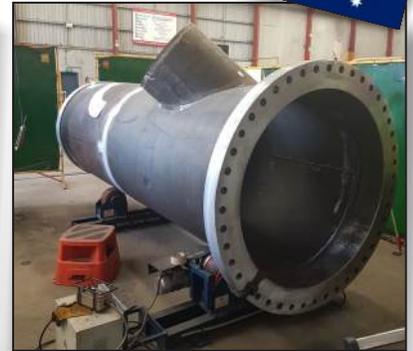
The seawater travels at a high velocity and the particulates in it cause erosion due to abrasion. Once these abrasion problems exist, the caisson begins to become ineffective.

It was decided that a newly fabricated caisson would be installed and before installation it would be protected from internal abrasion with CeramAlloy CBX.
