Midwestern Chemical Processing Plant Uses ENECRETE, ENECLAD & CHEMCLAD To Repair & Protect Concrete Tank Base

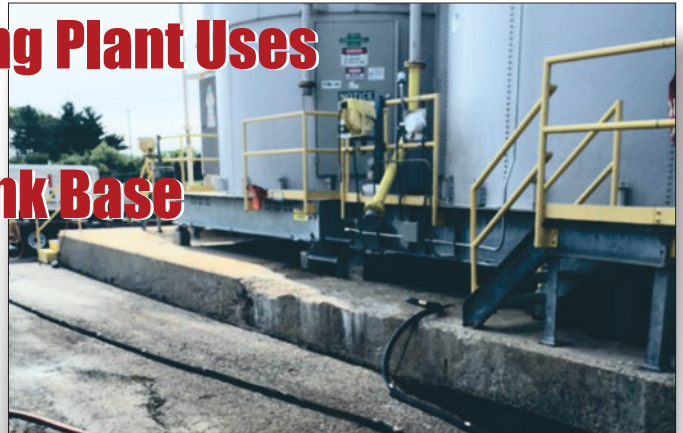
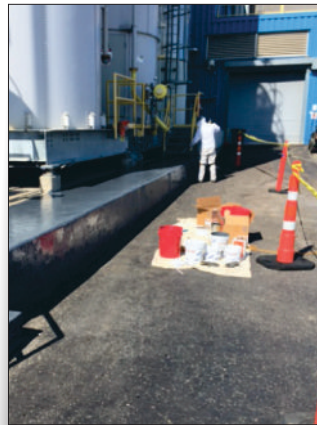
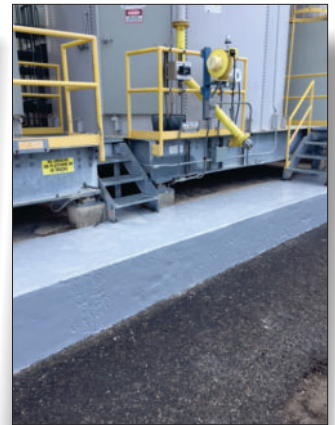
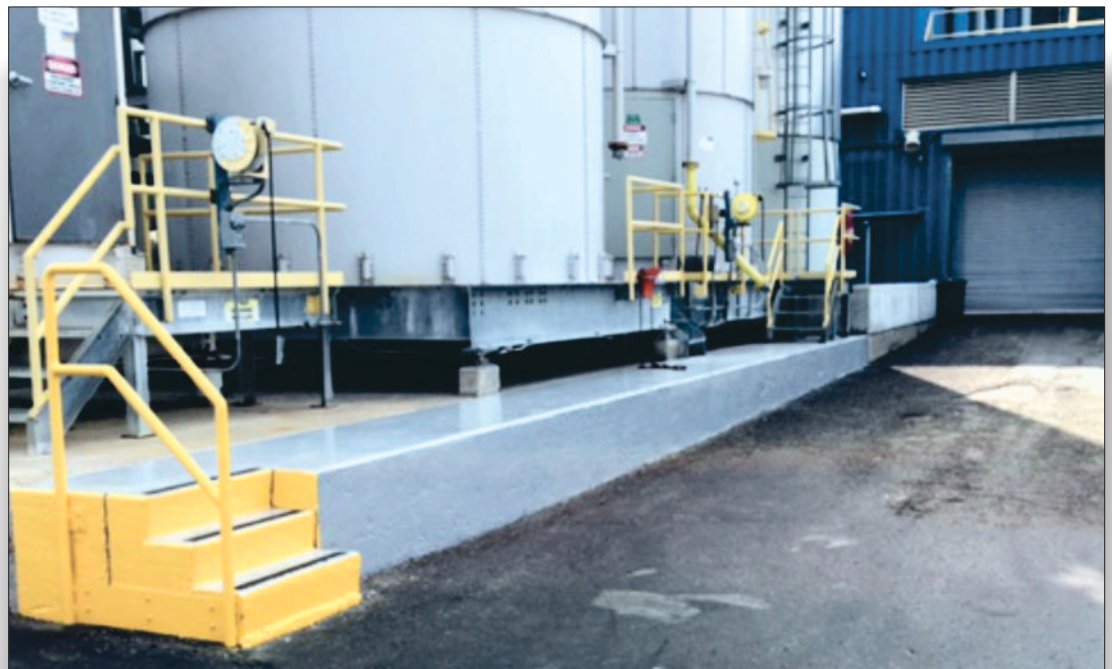
A concrete pad used as a base for six large storage tanks at a mid-western U.S. chemical processing plant was eroding from chemical attack and impact.

After pressure washing as well as vapor blasting to clean and remove contaminants, it was discovered that several sections had significant concrete loss. Vertical repairs were made with DuraQuartz LW whereas deeper damaged areas were repaired with DuraFill and a mixture of locally sourced pea-gravel and quartz sand.

The entire surface was then coated with a thin layer of ENECLAD SPS to level the area.

Finally, two coats of CHEMCLAD SC were applied. The stairs and railings were also coated with CHEMCLAD SC in safety yellow with the addition of aggregate back-rolled on the stair treads to provide slip-resistance.
