## Italian Chemical Company Repairs & Protects Concrete Storage Tank

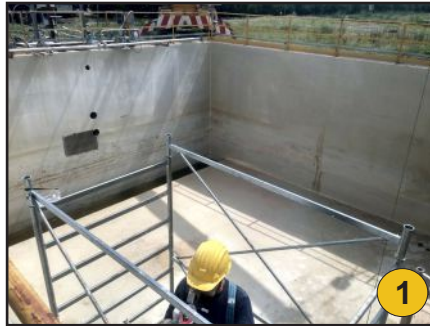
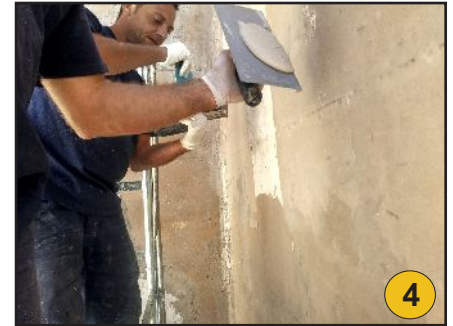
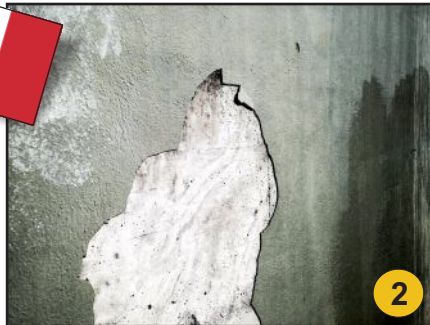
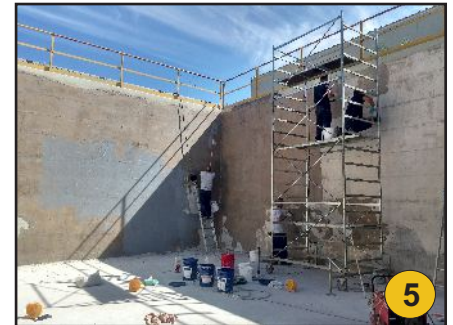
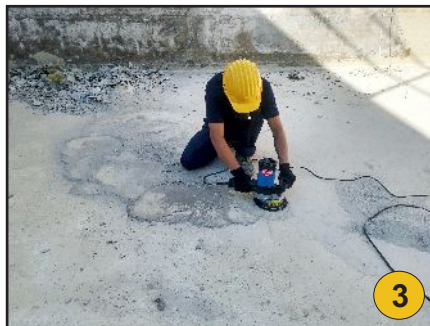
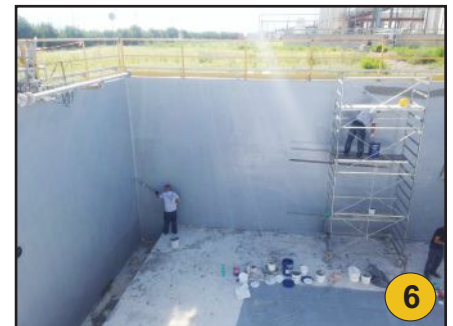
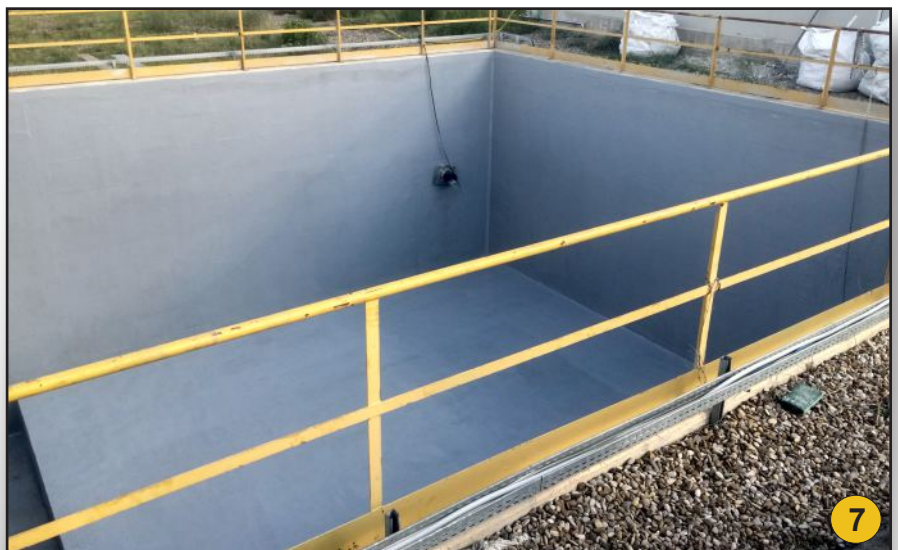
An Italian chemical processing company was storing waste chemical solutions in this large concrete tank. The aggressive nature of the chemicals was attacking the concrete and causing serious damage. The local environmental authority shut the tank down until it had acceptable chemical protection.

The surface was prepared by first removing all dirt, debris and loose concrete. All damaged areas were then repaired with ENECRETE Durafill mixed with a local aggregate.

The repairs to the tank took a total of 8 days; and, when completed, two coats of CHEMCLAD SC were applied by roller to completely protect the tank.
