## Automotive Parts Manufacturer Completes 'Classic' DuraQuartz Repairs

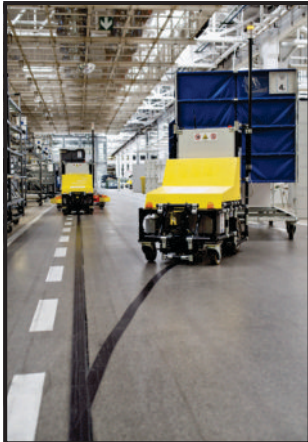
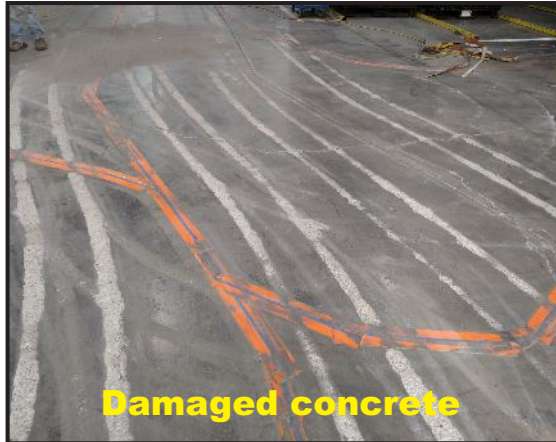
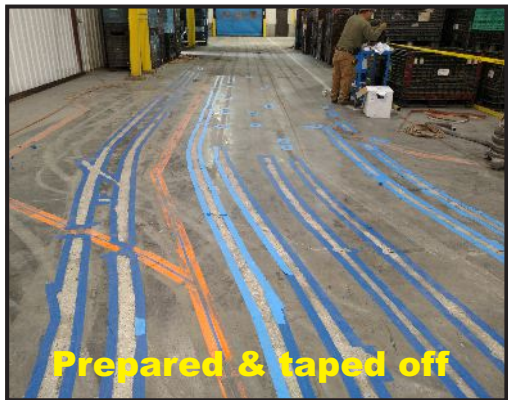
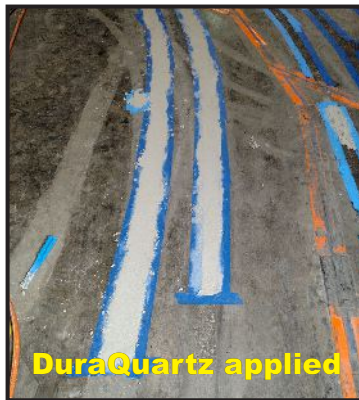
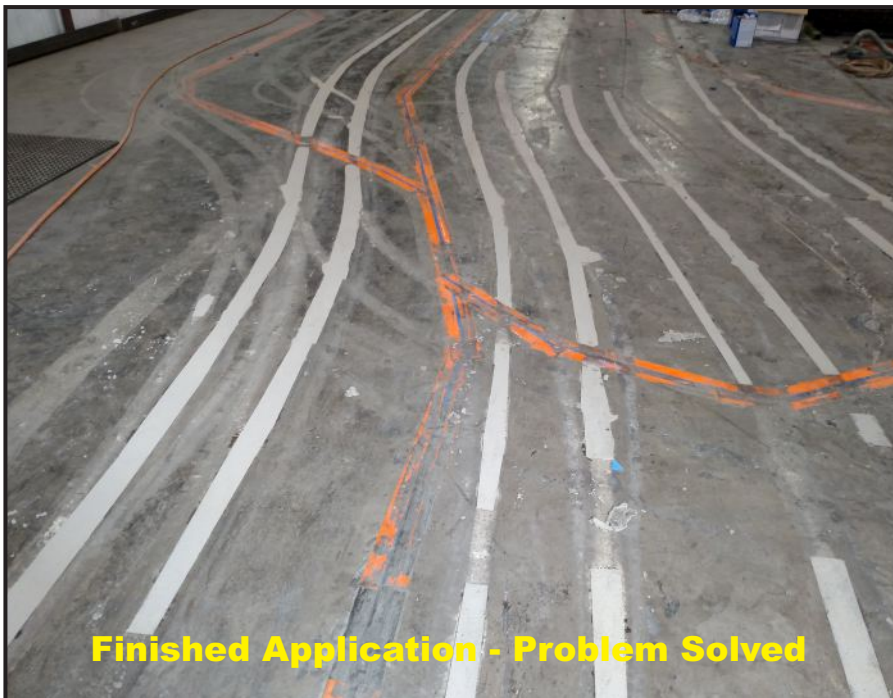
While this may not be one of the largest DuraQuartz applications, it is certainly one which is 'tailor-made' for it. This Tennessee manufacturer of automotive parts utilizes computerized 'trains' that run throughout the facility delivering and picking up parts all around the plant. These trains were cutting deep grooves in the concrete, causing the trains to veer off course and collide with other trains.

The plant engineers were looking for a high-performance concrete repair material that could be feather-edged and could withstand the heavy train traffic. Their local ENECON plant life extension specialist recommended ENECRETE DuraQuartz for this application. The plant's in-house contractor completed the repairs over the Memorial Day weekend with on-site support and training provided by their local ENECON representative.

The grooves were hand-ground and cleaned. Tape was used to define the repair areas and then the DuraQuartz system was applied. The plant engineers are 'very happy' with the repairs and additional projects have been scheduled at this facility.
