The Greek Navy Selects CeramAlloy & DurAlloy to Help Solve Some Very Difficult Repair Problems on Their Ships & Submarines

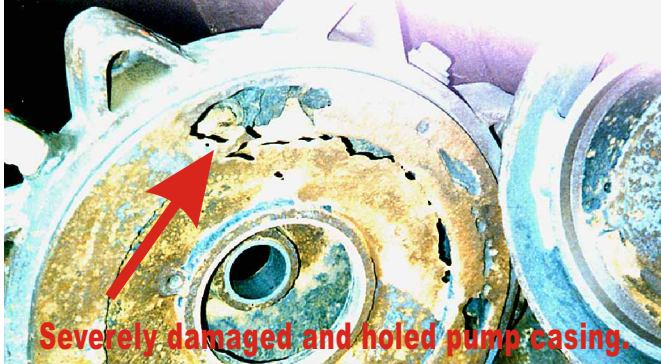
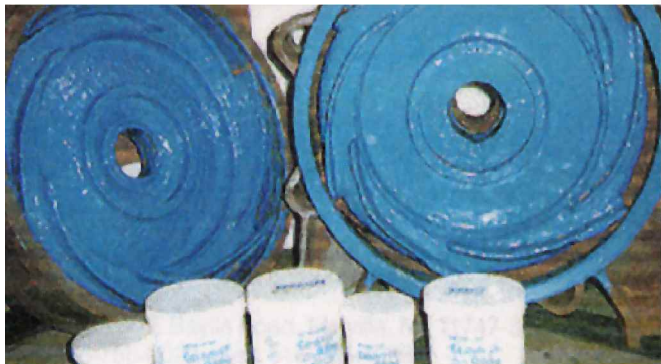
These fire pumps were completely destroyed by erosion and corrosion. METALCLAD CeramAlloy was used to rebuild and

resurface the pumps so that they can provide many more years of service to the Greek Navy.

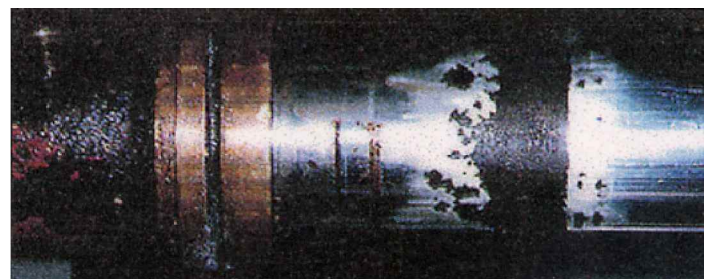
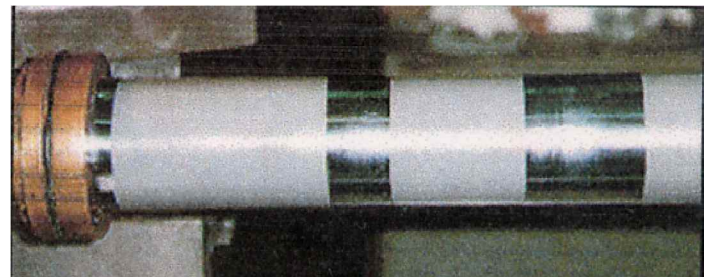
The second example highlights a repair to a damaged periscope piston from a Navy submarine. METALCLAD DurAlloy was used to rebuild the damaged areas saving the Navy a great deal of time and money when compared to conventional welding

or flame spraying repairs.

Of course, since DurAlloy requires **NO HEAT**, the danger of

warping the piston or creating metallurgical damage associated with welding was eliminated.
