Nuclear Power Station Saves Over \$20,000 Repairing Deteriorated Spool Piece with CeramAlloy

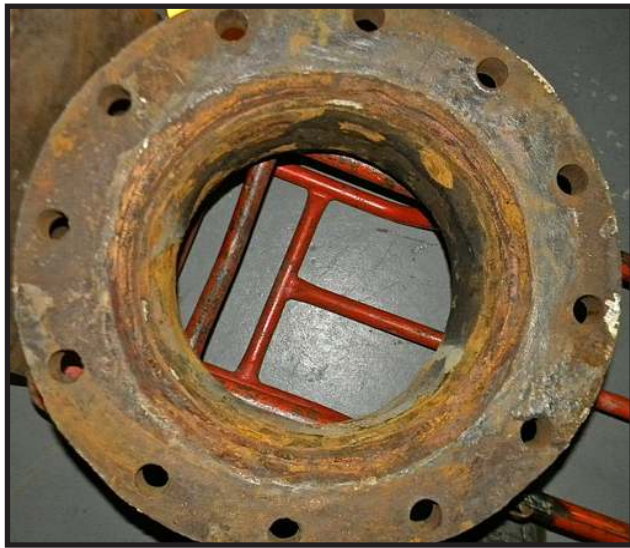
The component is a 14” diameter, cement lined, spool piece that is mounted between a large strainer and an isolation valve on the service water system at a nuclear power station. During a refueling outage, this spool piece was removed to allow for maintenance on an adjacent component. The deteriorated condition of the piece was unexpected. The cement lining was severely eroded as were the inside diameters of both the inlet and outlet flanges.

The onsite ENECON Northeast service team, was asked to accomplish abrasive blasting of the component so that plant engineers could make an assessment of the true condition. Once the spool piece was determined to be structurally sound, **METALCLAD CeramAlloy CP+** was used to rebuild the spool lining and damaged flanges and **METALCLAD CeramAlloy CL+** was used to totally encapsulate the surfaces exposed to the brackish river water.

The spool piece was ready for re-installation just two days after removal at a fraction of the cost estimated for replacement - an excellent example of the practical benefit of “Repair don’t Replace”!
