## Mexican Silver Mine Reconditions Tanks For Potable Water With CHEMCLAD SC

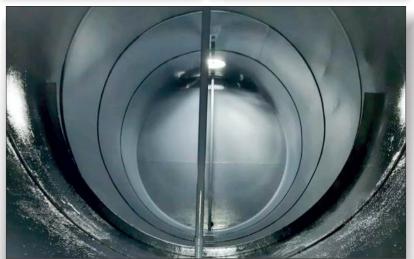
This tank recovery (reconditioning) project was recently completed for a prominent silver mining company located in Mexico. These tanks were originally used for fuel storage but after many years in service they were no longer necessary due to sufficient supply from external suppliers. The tanks were taken out of service and removed from the area.

The tanks were first blast-cleaned to a white metal finish / 3 mil profile. After wiping all the grit blasted surfaces with a suitable solvent, two coats of CHEMCLAD SC were applied by brushes and rollers.

The local ENECON
Distributor
reconditioned the
tanks for potable
water use.
CHEMCLAD SC was
used because it is
NSF approved for
drinking water
applications.

The customer only wanted to coat the inside of the three tanks, but they are also now interested in coating the outside of these tanks and many other potential applications after the ENECON Team exceeded the mining company's expectations on this initial project.
