Veterinary Hospital Revives Hallway Walls With Low-VOC CHEMCLAD GP

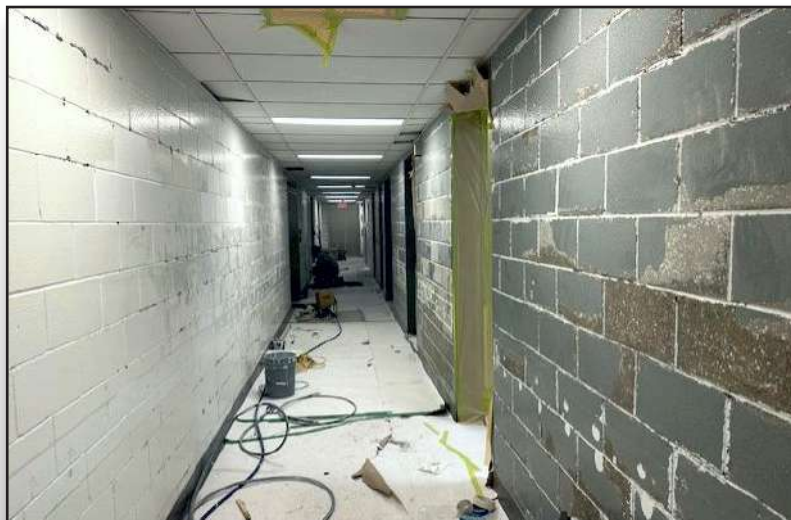
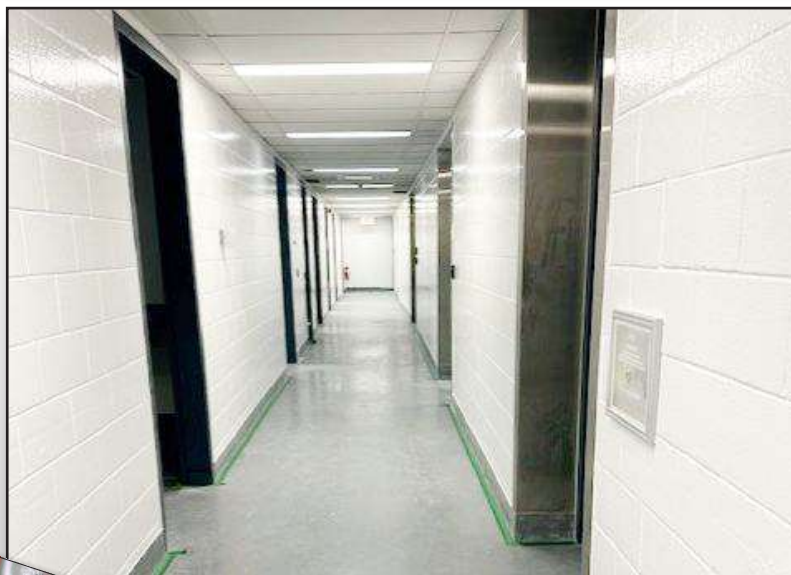
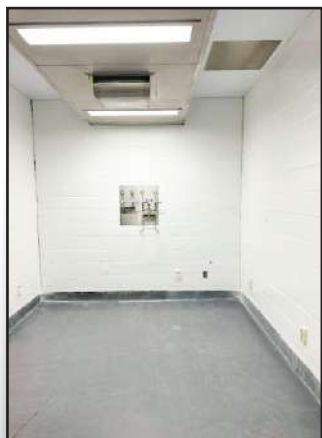
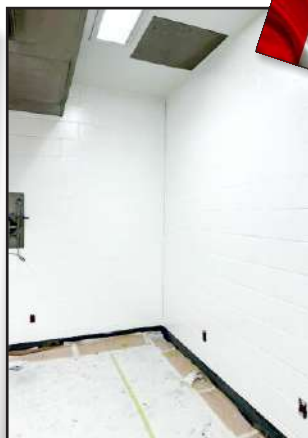
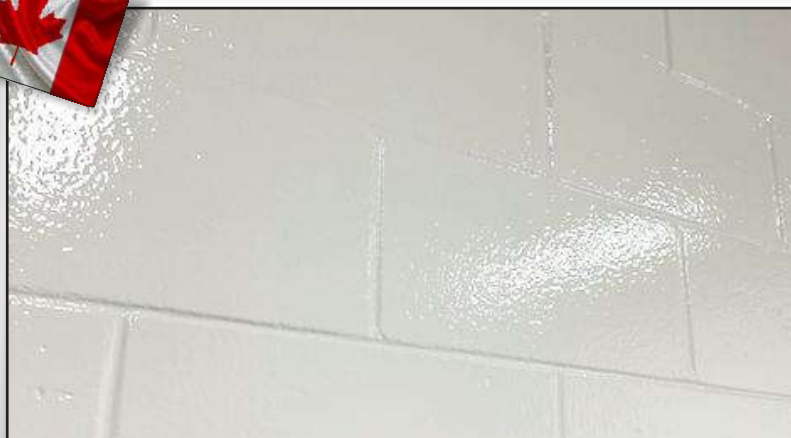
A busy hallway in a Canadian veterinary hospital was showing severe wear: peeling, chipped, and scratched paint created hygiene concerns as well as an unsightly appearance.

To prepare the surfaces, the application team first scraped away all loose paint. They then used dry ice blasting, a clean alternative to grit blasting that avoids the release of airborne particles and secondary waste, which is critical in a clinical setting.

Two coats of **CHEMCLAD GP** were applied, transforming the hallway with a fresh, uniform finish. In addition to improved aesthetics, the low-VOC coating provided lasting protection and helped maintain a healthier air quality standard for the hospital's animal patients.
