Hospital Saves Almost \$500,000 By Repairing Damaged Concrete With DuraFill Instead Of Replacing It

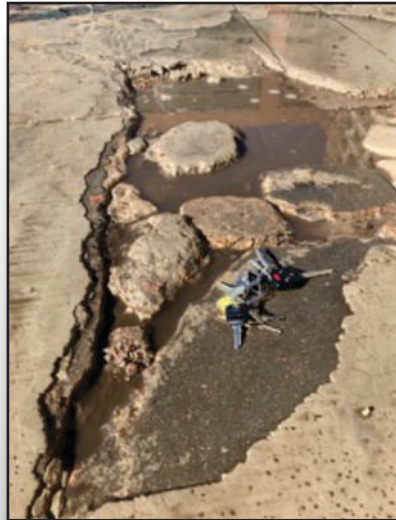
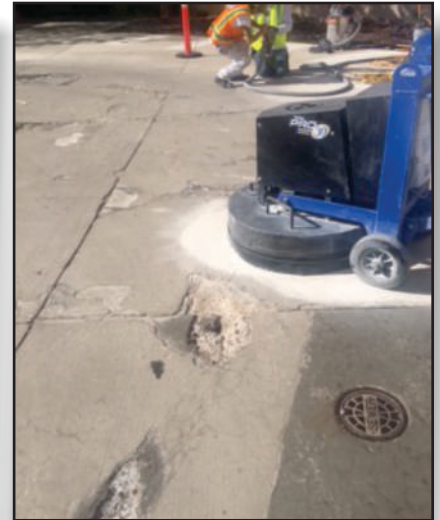
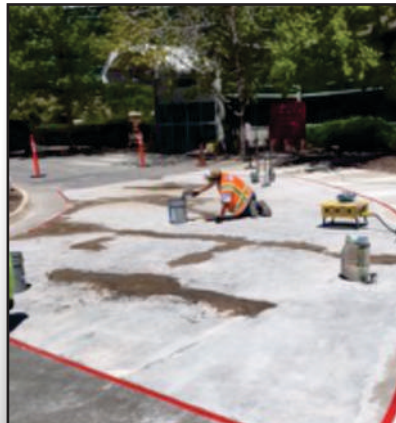
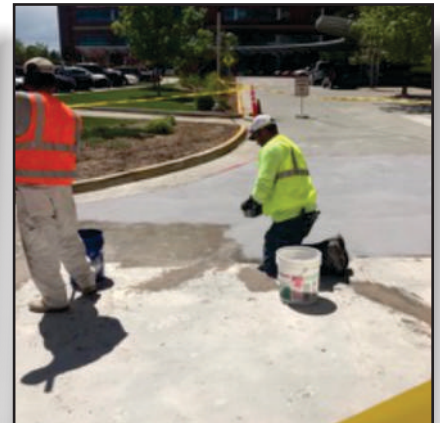
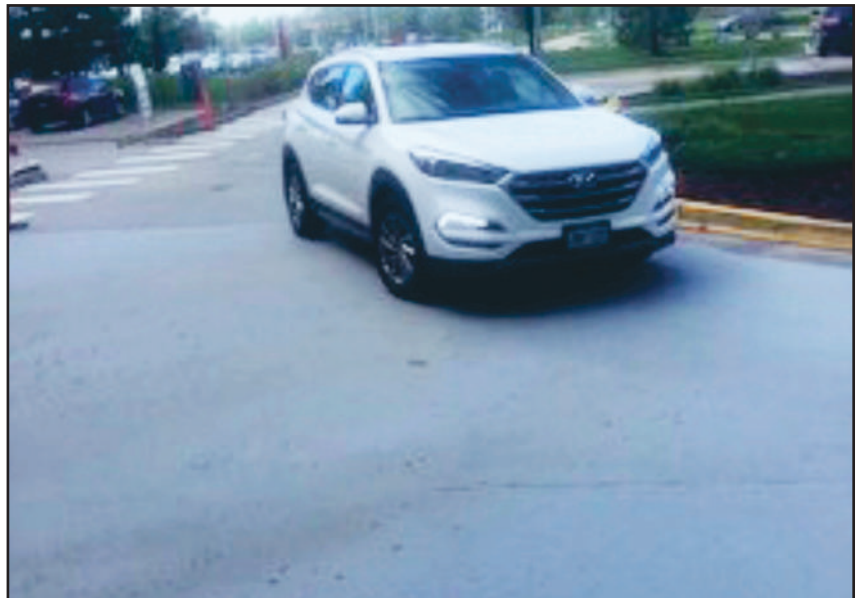
The main driveway at this Colorado hospital had slowly begun to erode over the years. Severe weather, freeze/thaw and ice melt had caused dozens of potholes. Some of the potholes were as large as four feet in diameter and up to six inches deep.

Repeated attempts to patch the pot holes and resurface the entire driveway with a thin layer of a “super industrial, cementitious substance” had all failed.

The first step was to remove the failed thin layer by using a large grinder. All loose material inside the potholes was removed and the holes were filled with *DuraFill* mixed with common play sand.

Finally, two broadcast applications of *DuraFill* and colored aggregate were applied to achieve the desired color.
