Garage Floor In Canada Transformed With ENECRETE DuraFill Decorative Broadcast Flake & Non-Skid System

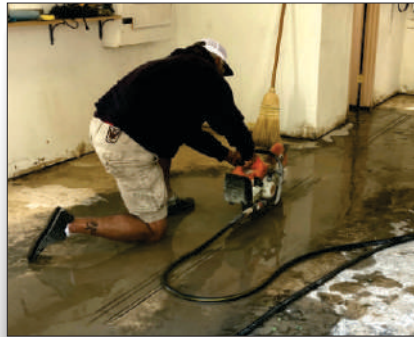
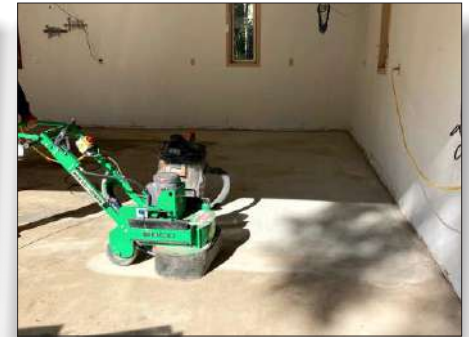
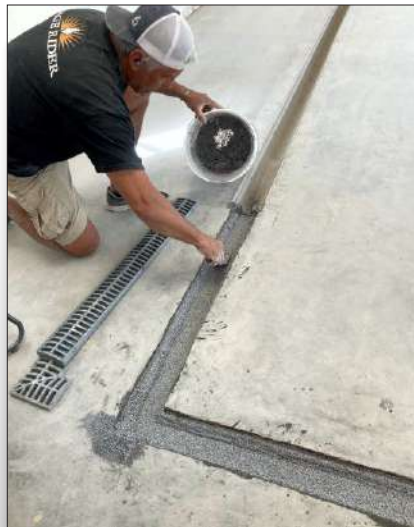
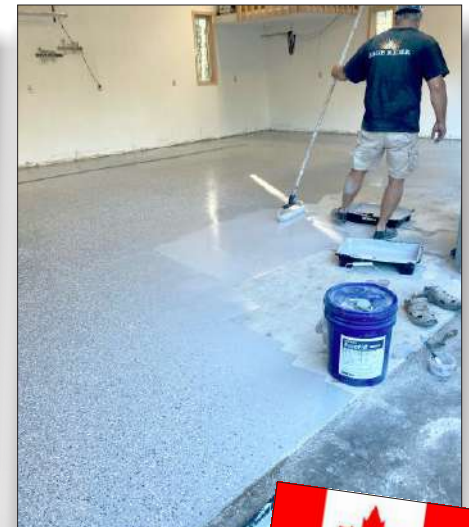
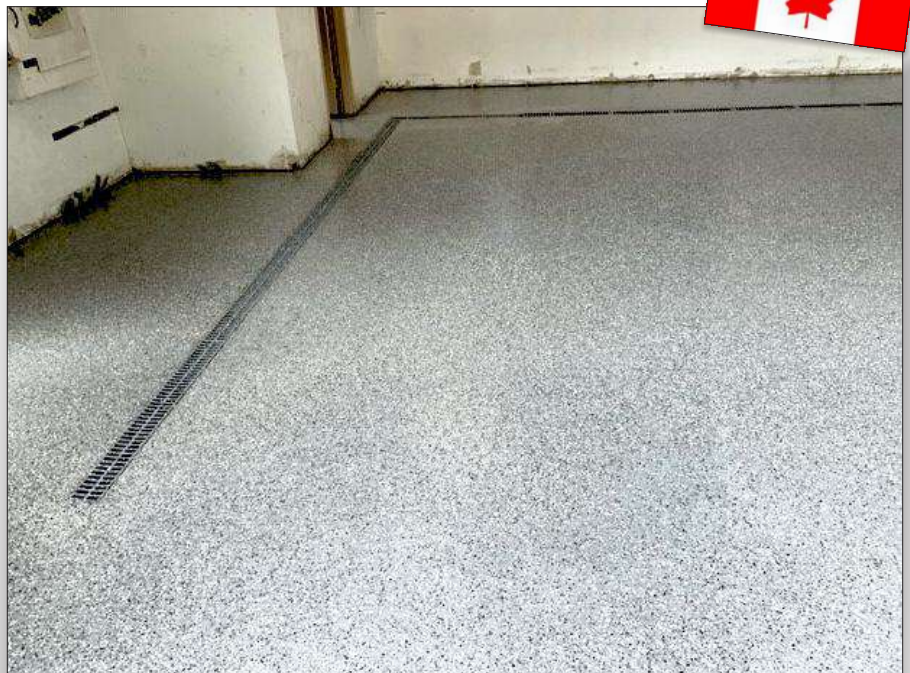
The floor drain in this Canadian garage was not sufficient. The winter snow would melt off of the equipment stored there and migrate to the walls causing mildew and damage to the drywall.

The drain was extended by using a concrete saw. After the cuts were made a jackhammer was used to remove the concrete from the cut sections. After a thorough cleaning, ENECRETE DuraFill was mixed with a local aggregate and the newly cut drain trench was sloped to promote proper water flow towards the existing drain.

This DuraFill mixture was also used to make sure the grates

were level to the floor and fit properly into position.

While the DuraFill in the trench cured, a grinder was used to prepare the floor. Durafill was then mixed, tinted gray and applied. Multi-colored polymer flakes were then applied at a coverage rate of 30% creating a decorative, and seamless flooring/drainage system.

The next day Durafill was applied as a clear topcoat for two reasons: 1: to seal the polymer flakes 2: to create a non-skid surface by back-rolling in aggregate.
