Concrete Vertical Pump Bases Repaired With ENECRETE DuraFill

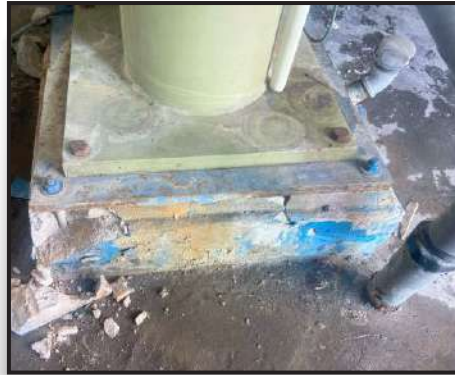
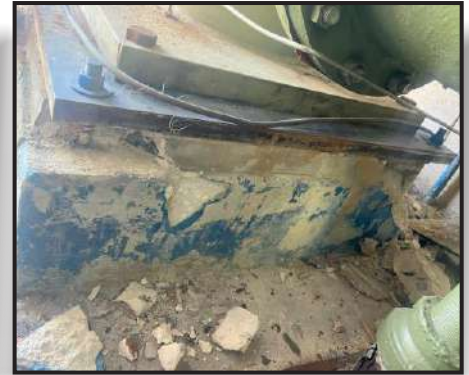
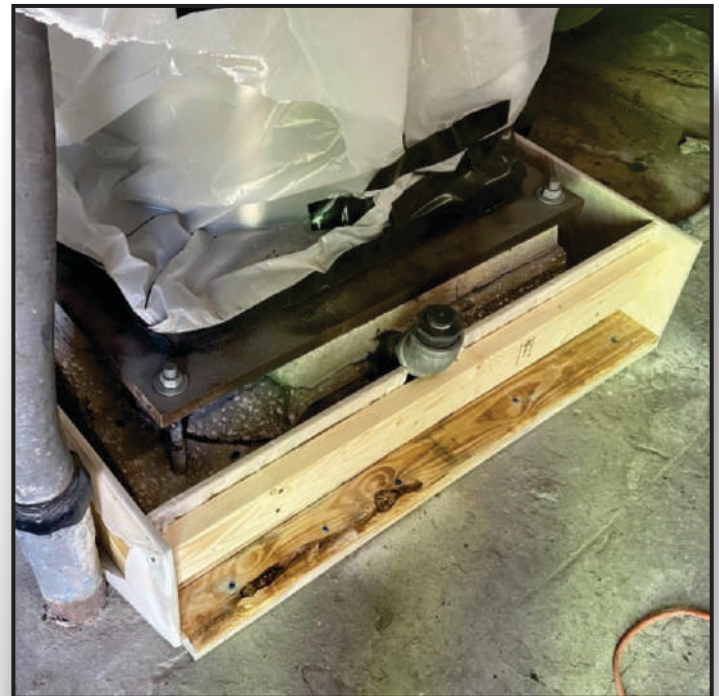
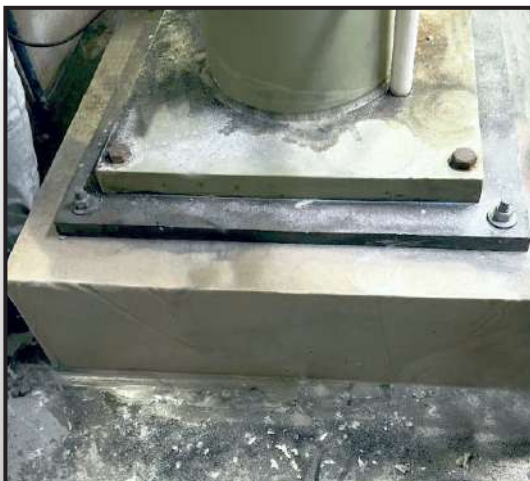
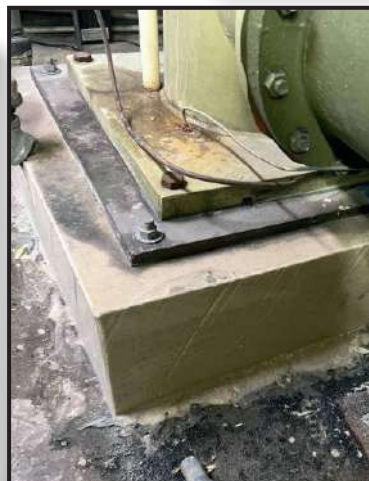
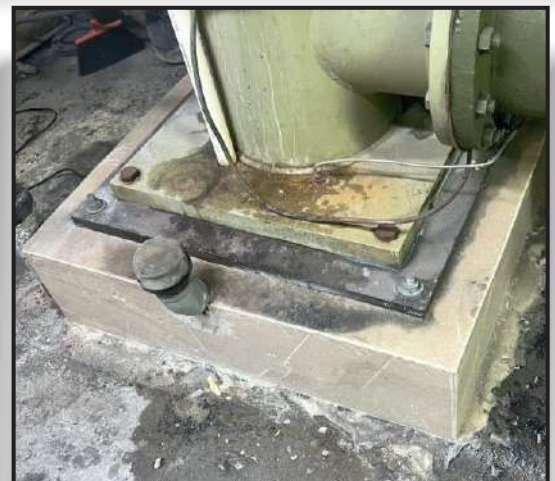
This concrete base supports a 350 hp, high-service vertical pump at a Florida water treatment facility. This type of pump has a total load of over 12,000 lbs. The municipality required a product with a high compressive strength and short downtime to complete this repair. The maintenance engineers at this facility had tried conventional repairs to similar bases and failed.

Removal and rebuilding pumps of this type is costly and time-consuming, so very often, customers run the pumps to failure while increasing the pump load, which causes severe

vibration and stresses the concrete bases until they break.

All the loose concrete was removed for the repair, and the remaining concrete was abrasive blasted. A form was made, and lag bolts and additional rebar were installed. ENECRETE DuraFill mixed with silica sand was poured into the former, creating the new base.
