Mexican Mining Company Repairs & Reclaims 16 Flotation Tanks & Support Structures With CHEMCLAD SC & ENESEAL CR

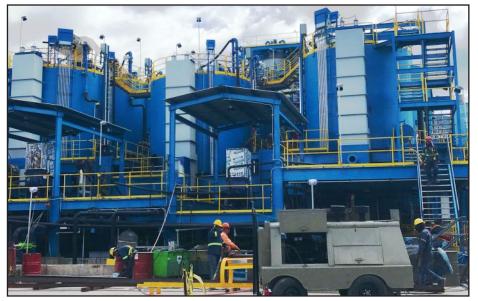
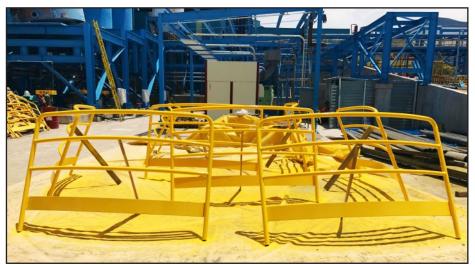
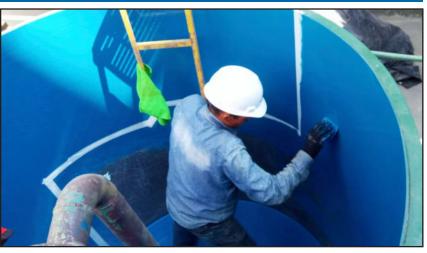
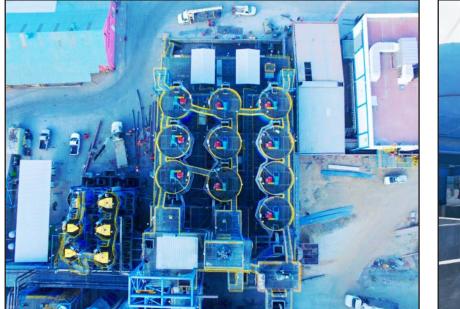
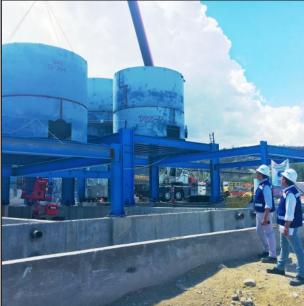
These flotation tanks and equipment were not in use for over 7 years. The mining company, one of the largest in Mexico, wanted to recondition this equipment and put The entire cost of these 16 flotation tanks back in service quickly as well as cost effectively.

The local ENECON Distributor in the region recommended that ENESEAL CR be used to protect all the exterior surfaces of the tanks as well as all been no corrosion the support steelwork to protect these from future corrosion attack.

Internally, all the tank walls, drains and loading areas were reconditioned and protected with CHEMCLAD SC.

CeramAlloy CL+AC was also used to repair and protect all areas subject to very severe erosion / corrosion conditions.

This project was completed over one year ago and recent inspections have confirmed that there has or wear issues during this time. The plant engineers are extremely happy with these results.
