ENECON Italia

Saves 90-Year Old Pump For The Italian Navy

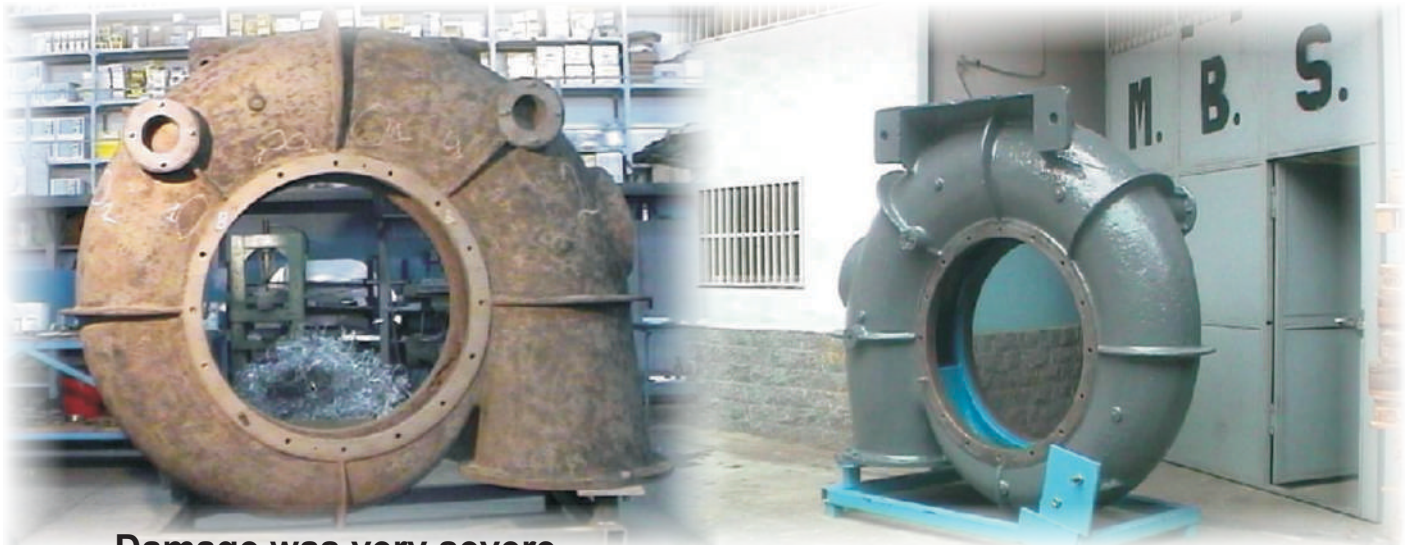
This huge, 90-year old, cast iron pump casing and impeller from an Italian Navy dry-dock were so severely eroded and corroded that the facilities engineers had decided to scrap it and order a new pump. The \$100,000 price tag for a new pump, however, persuaded the engineers to have the components rebuilt with ENECON High Performance Polymer Composite materials by the skilled engineering team at ENECON Italia.

The deeply pitted casing was first grit blasted then "primed" with CHEMCLAD GP. The

very deep pits were rebuilt with DuraQuartz and the entire surface coated with two coats of CeramAlloy CL+ [AC]. The outside of the casing was also protected with two coats of CHEMCLAD GP.

The damaged impeller was rebuilt with DurAlloy and then protected from future erosion and corrosion damage with two coats of CeramAlloy CL+ [AC].

The entire project was carried out at ENECON Italia's workshop in Naples at less than 10% of the replacement cost for a new pump.

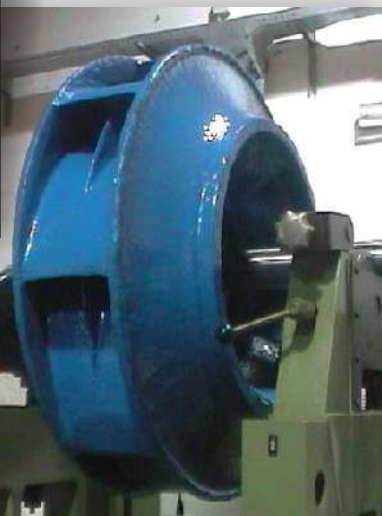
Damage was very severe
