ENECON's DuraWrap Carbon Fiber Pipe Wrap System Repairs & Protects Large Water Treatment Plant Pipes

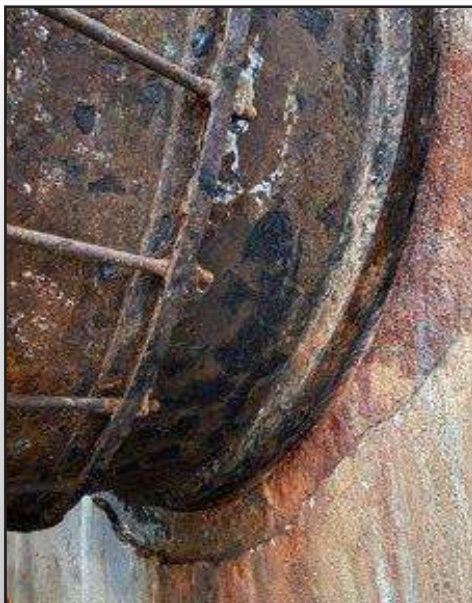
Large, underground pipes located at a water treatment plant in the northeastern US were leaking after years in service and gradual corrosion. The plant needed a solution that would not only stop the leaking, but also protect these pipes from future corrosion issues.

Before

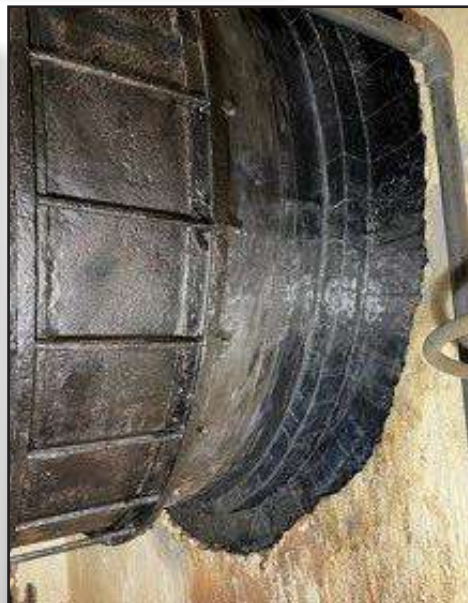
DuraWrap applied

white metal profile. Since the pipes remained in service, any active leaks were stopped with METALCLAD SpeedAlloy QS and SpeedAlloy. Any other problem areas with pitting or corrosion damage were repaired with the DuraWrap Primer.

The carbon fiber was then applied to the pipes to restore their integrity. A final encapsulation with ENESEAL CR was done to help prevent any surface corrosion on the pipes in the years to come.

The pipes were first grit blasted to a 3 mil,

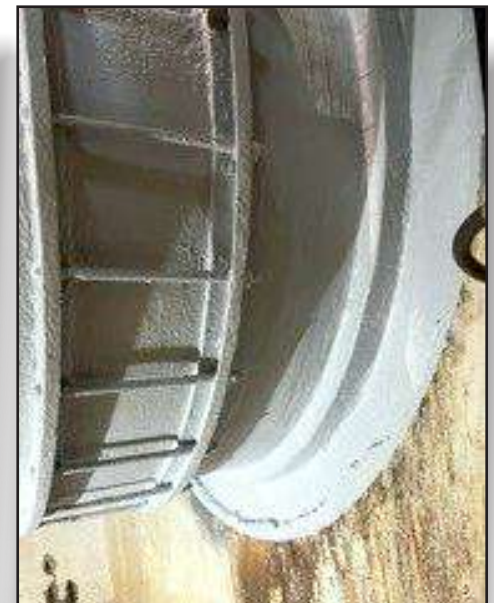
Encapsulated with ENESEAL CR
