## CeramAlloy Used to Protect New Vertical Pump Column Headed To Texas Energy Plant

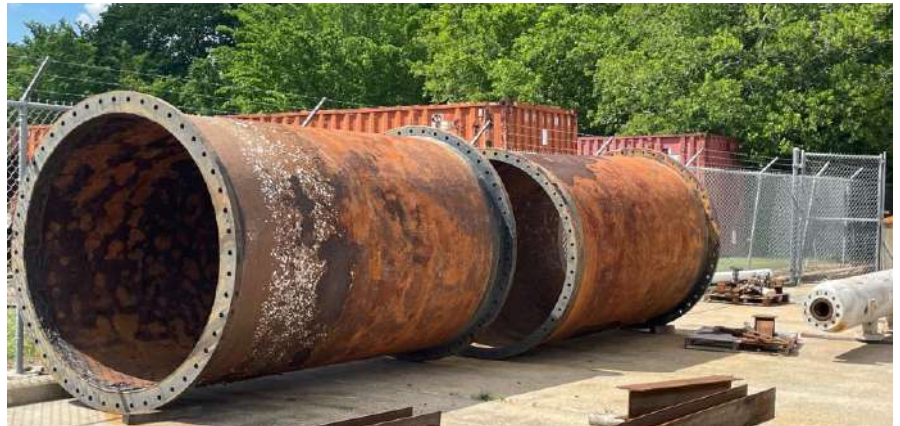
This vertical pump column is 6.5 feet in diameter and 22 feet long. It had been in service for many years at a Texas power plant pumping brackish cooling water to a steam condenser.

As you can see in the top photo, the corrosion was so severe the it could not be repaired and it was taken out of service. The walls of the column had become too thin and would not meet standards.
