Maintenance

Sustainable, economical solutions to replacement

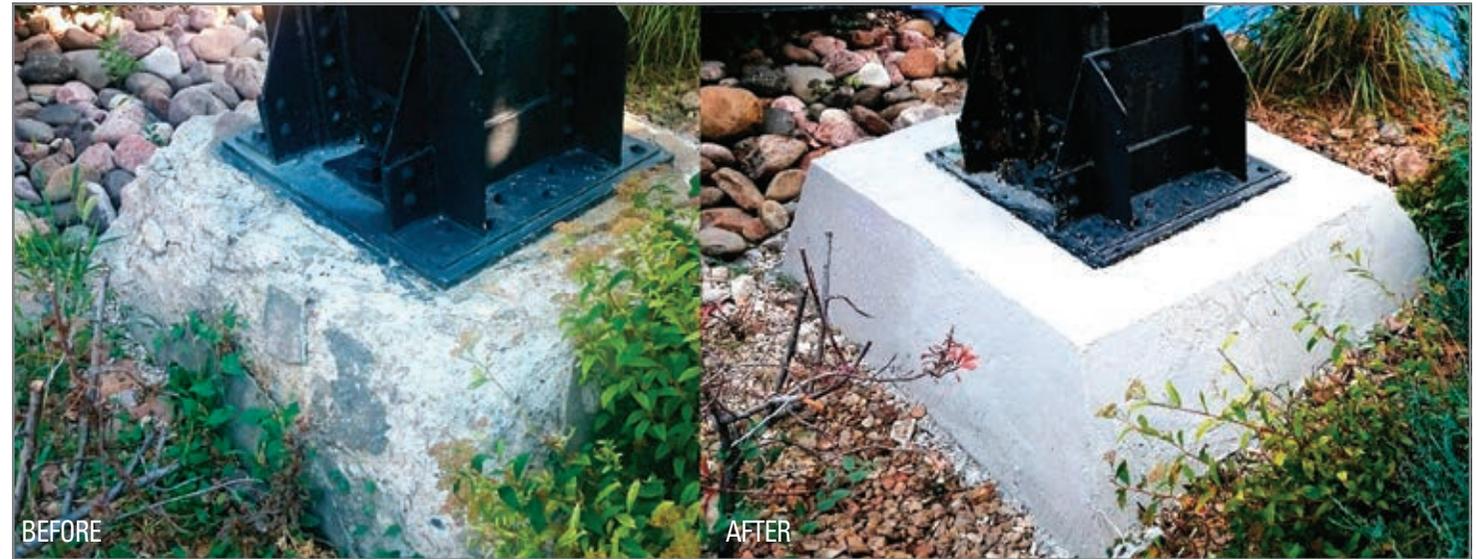
The applicability of concretelike polymer-based materials is widespread and can be beneficial when setting, securing or repairing areas around handrails, metal stair noses and footers.

The applicability of these concretelike polymer-based materials is widespread. The bond strength of these type of systems to concrete often is greater than concrete's ability to bond to itself. These types of materials also bond to metallic surfaces, which is beneficial when setting, securing or repairing areas around handrails and metal stair noses. There is zero shrinkage during the curing process; consequently, the material can be easily formed. Also fast set-up times make these systems applicable in a wide range of applications.
