ENECRETE, ENECLAD & CHEMCLAD Repair & Protect Containment Areas at Chilean Power Plant

Client: 900 Megawatt Thermoelectric Plant

Location: Chile

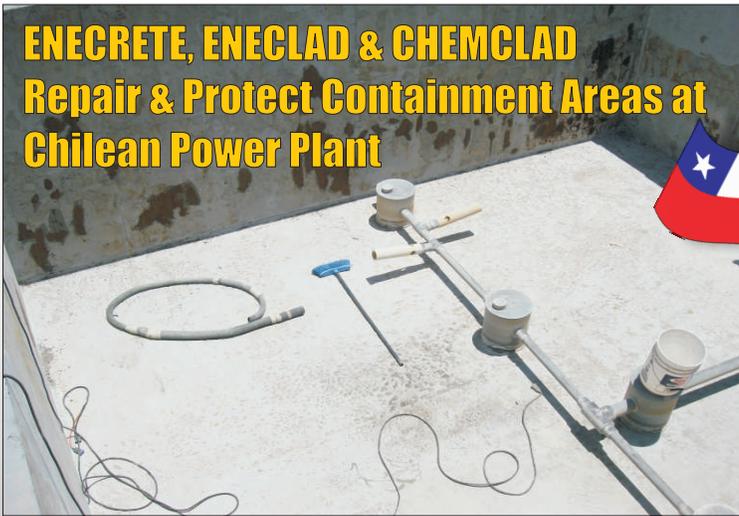
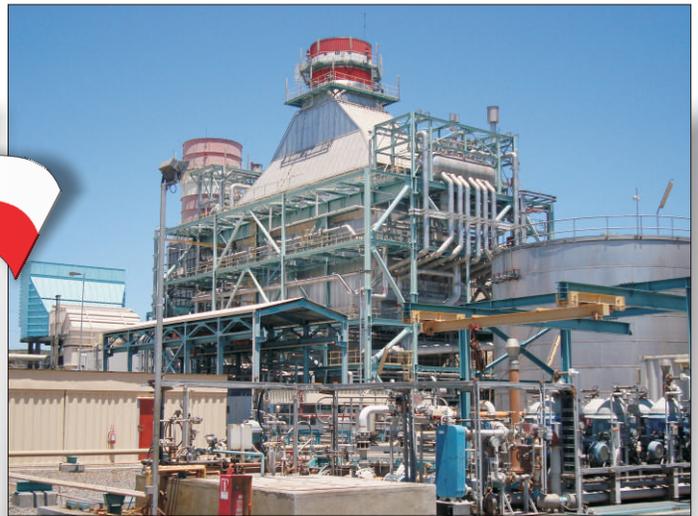
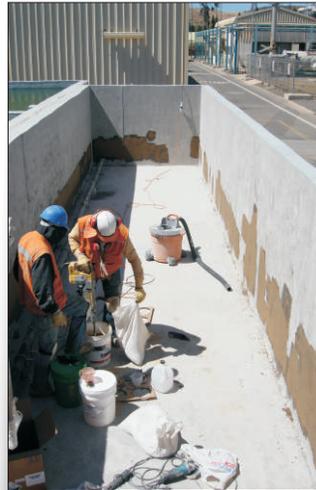
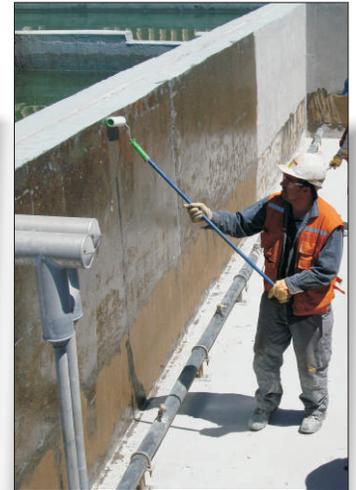
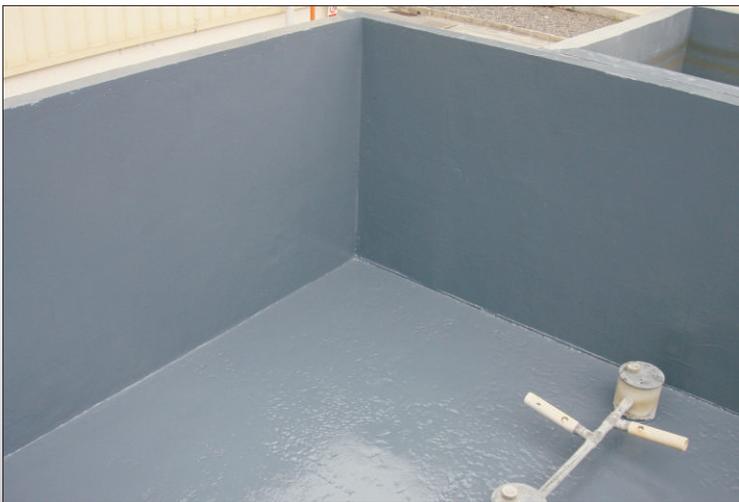
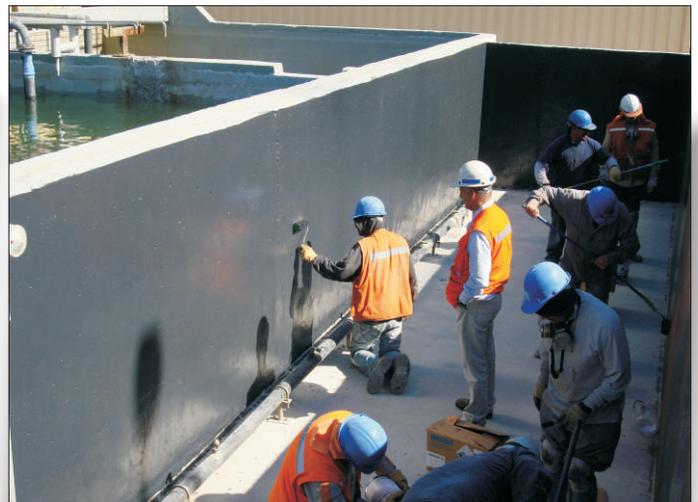
Problem: Corrosion of 3 concrete acid containment areas.

Solution: After mechanically cleaning concrete walls, ENECRETE DuraFill was used to repair all damaged areas. ENECLAD CFS was then applied followed by two coats of CHEMCLAD XC for maximum protection.
