Desalination Plant in Cyprus Uses ENECRETE & CHEMCLAD to Stop Sulfuric Acid Attack

Client: Desalination Plant

Location: Cyprus

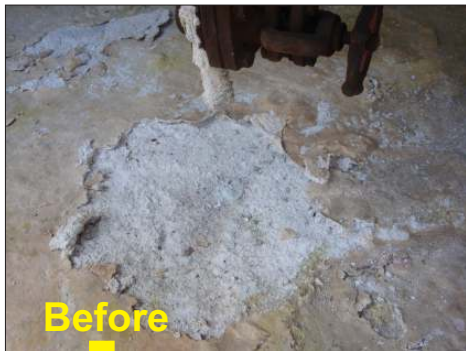
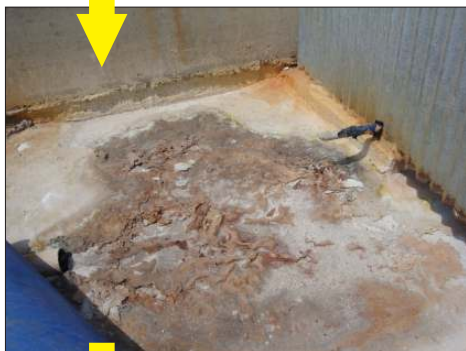
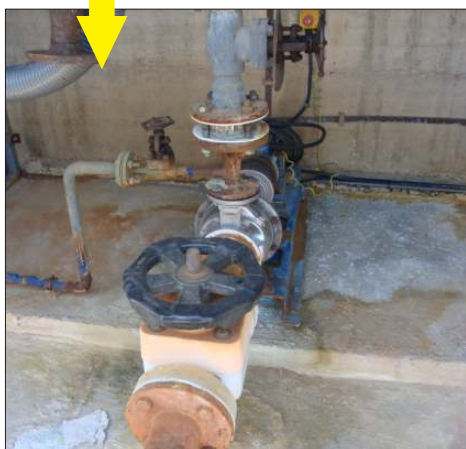
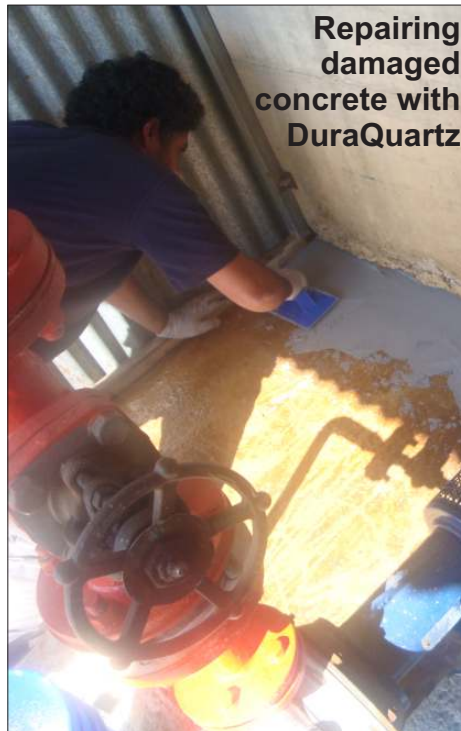
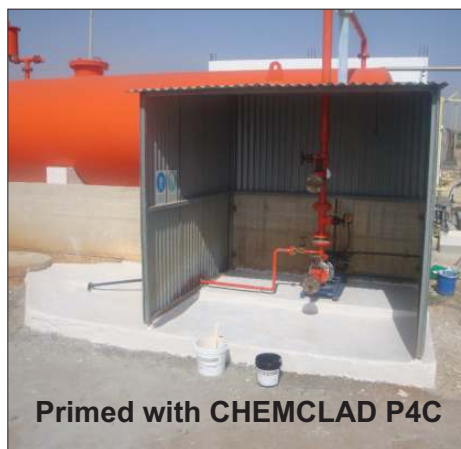
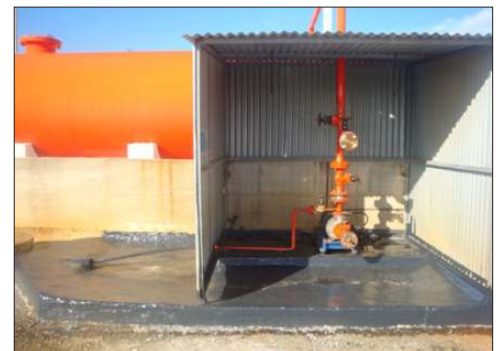
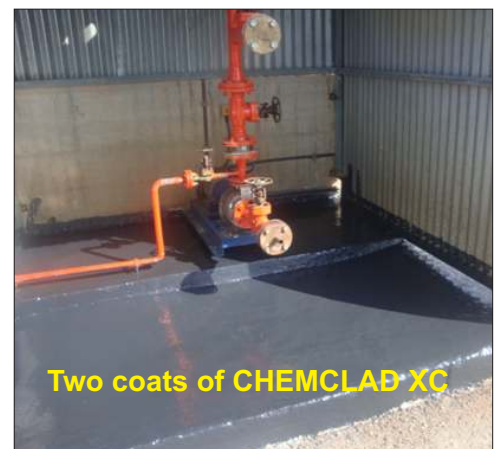
Problem: Sulfuric acid pump drip had badly damaged the cement base it sat on.

Solution: Damaged concrete was repaired with ENECRETE DuraQuartz. CHEMCLAD P4C was applied as a primer to the concrete. Two coats of CHEMCLAD XC we then applied to provide optimum chemical resistance.
