CHEMCLAD GP Continues to Fight Corrosion on Waste Removal Trailers

CH-066

Geothermal Power Plant Uses CHEMCLAD SC to Stop Corrosion on Waste Removal Trailers

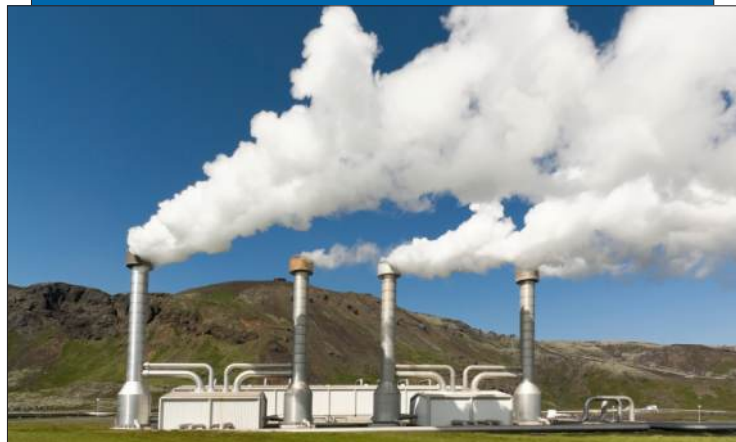
CHEMCLAD GP was used to protect new and used waste removal trailer beds used at a California geothermal power plant.

The trailer beds were grit blasted and two coats of CHEMCLAD SC were sprayed onto the 550 sq ft beds.

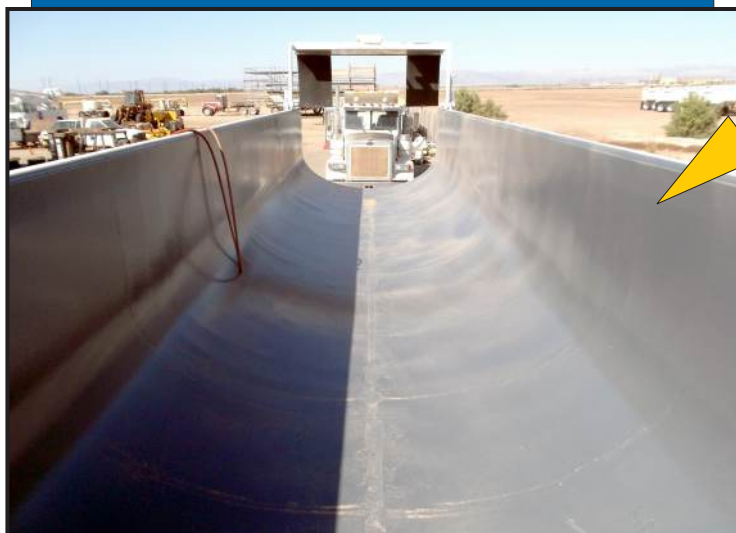
1 Year in Service and Counting... Still Looking Good

After one year in service transporting extremely corrosive brine mineral debris, the trailer beds are showing no signs of corrosion. Other products previously tried only lasted a few months.
