## Commuter Rail Platform Steps Repaired & Protected With ENECRETE & CHEMCLAD

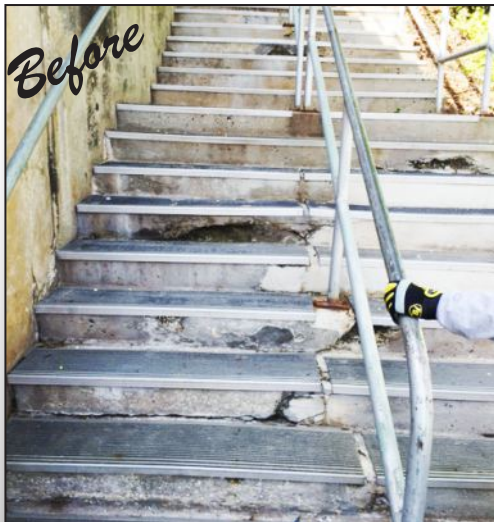
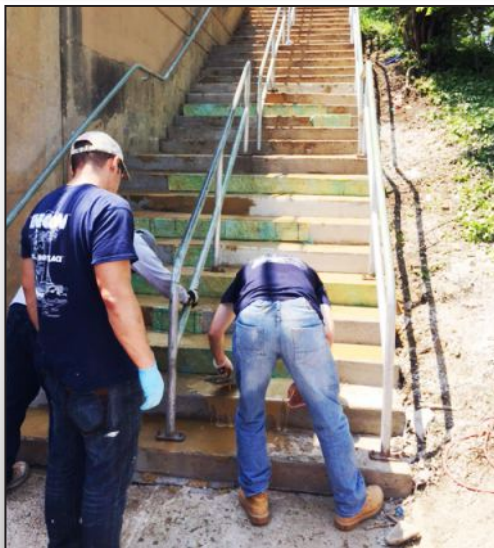
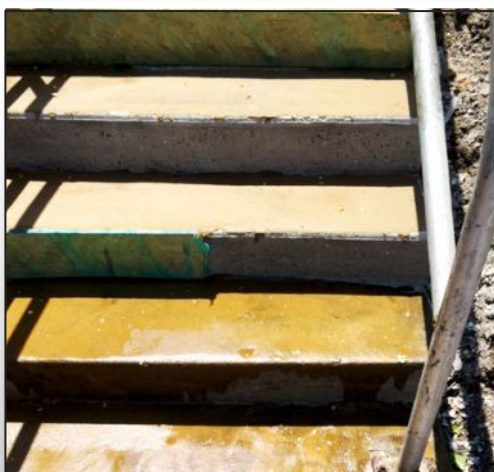
These station platform steps were in very bad condition after years of use and harsh northeastern winters. The concrete was deteriorating causing an unsafe and unsightly area.

After manual preparation and cleaning, lost

concrete on the treads and toe kicks was repaired using DuraQuartz LW. DuraFill was then used over the entire stair case to create a uniform surface. The steps were then coated with 2 coats of CHEMCLAD SC back

rolled with aggregate to provide slip resistance.
