ENECON Continues to Assist with the Repair of this 27 Year Old Seattle Cooling Towers

Corroded Steel Cooling Tower Support Beams Are Protected With ENESEAL CR

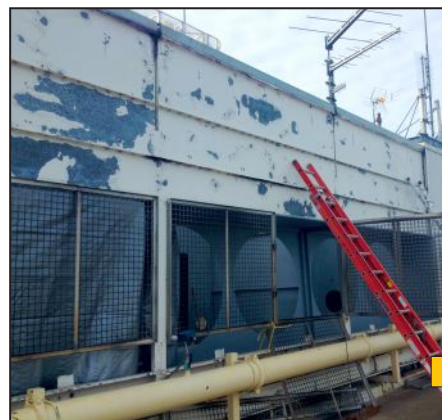
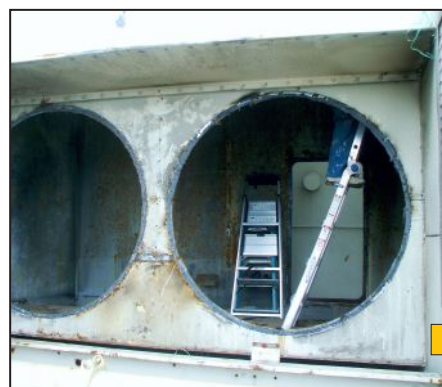
The towers were first stripped of all equipment, fill, etc. to provide access for the ENECON Turnkey Application Team to adequately prepare all the interior metal, address holes and preserve the substrate.

Once surface preparation was complete, all holes were repaired with

METALCLAD DurAlloy. Two coats of *CHEMCLAD SC* were then applied to the internal structure of the cooling towers to provide long-term protection and extend the service life of these crucial pieces of equipment.

Once the interior was complete, critical areas of the exterior were coated with *ENESEAL CR* to provide corrosion protection to the outside of these units from the elements.

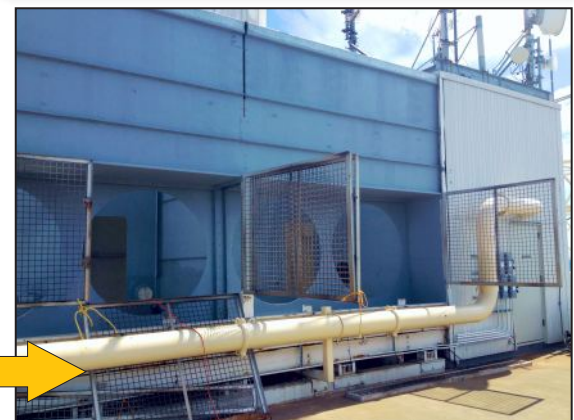
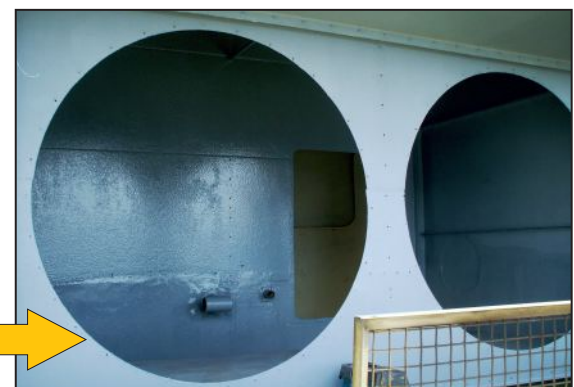
A downtown Seattle office building has these large cooling towers on top of galvanized support beams. The beams were corroding due to the environmental conditions in which cooling towers historically operate.

The support beams pictured had been painted with a "high-quality" marine paint just one year prior to this project taking place. The previously applied paint was already peeling off due to the prior coatings' inability to bond to the galvanized surface of the support beams.

The beams were first prepared by pressure washing and then hand grinding was used to remove any remaining paint and rust. Once the surface was properly prepared, two coats of ENESEAL CR, tinted to a
