CHEMCLAD SC Protects Concrete Containment Area From Exposure To Sodium Hydroxide

Wastewater treatment facilities use caustic chemicals in their processes daily. At this Texas facility, the fiberglass lining of a sodium hydroxide tank containment area needed to be replaced.

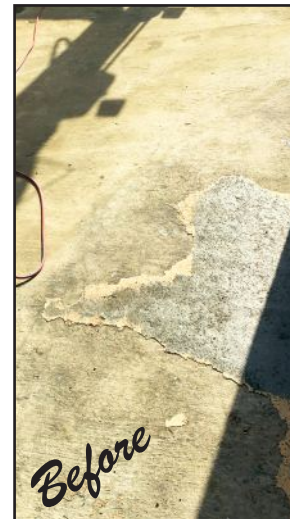
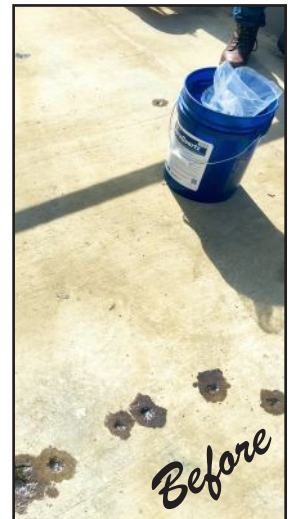
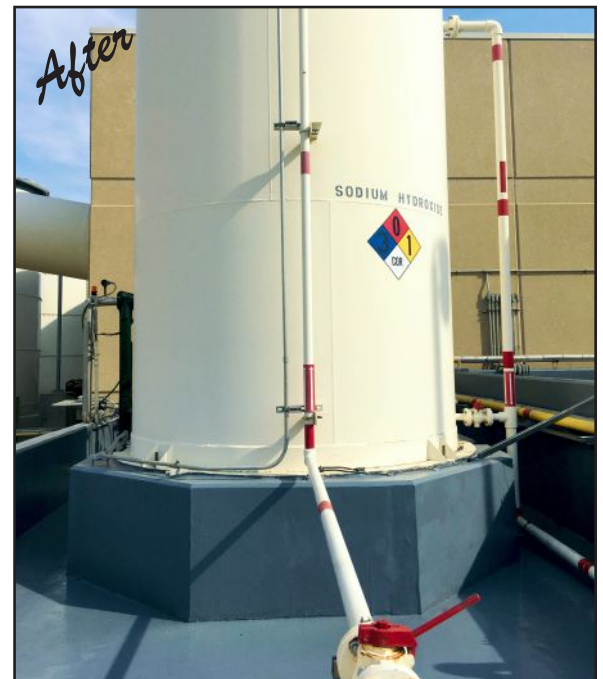
Several areas of concrete also needed to be repaired because of direct contact with the chemical.

The fiberglass liner was completely removed and the surface of the concrete was ground down to a 'roughened' profile. It was then cleaned of any loose debris.

ENECRETE DuraQuartz was used to patch all the damaged concrete areas. The entire area was then primed with *CHEMCLAD P4C*.

Because of its outstanding corrosion and chemical resistant properties, two coats of *CHEMCLAD SC* were applied over the entire interior surface of the containment area.
