Northeastern U.S. Power Company Saves Concrete Electrical Tower Base with ENECRETE & ENESEAL

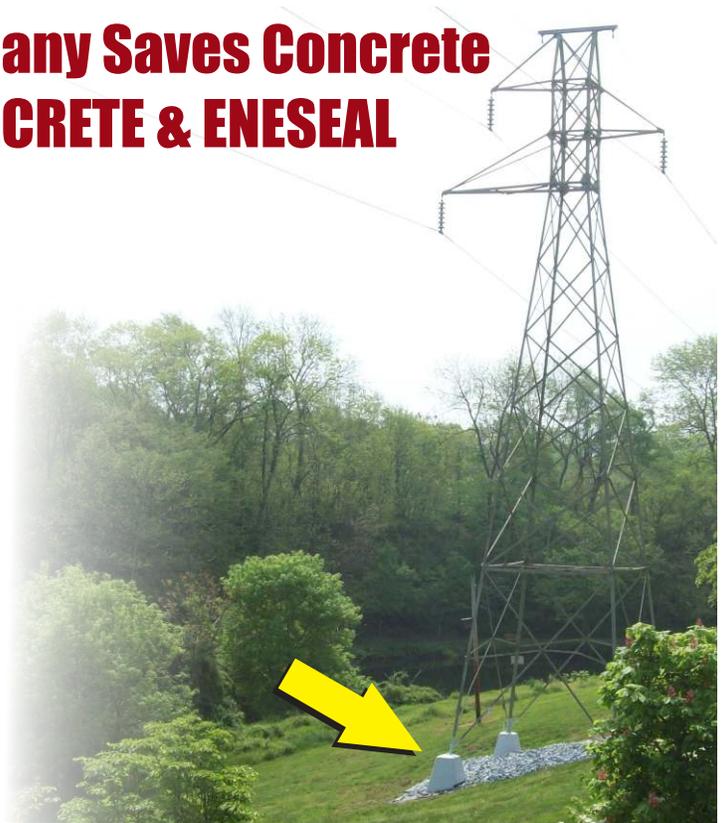
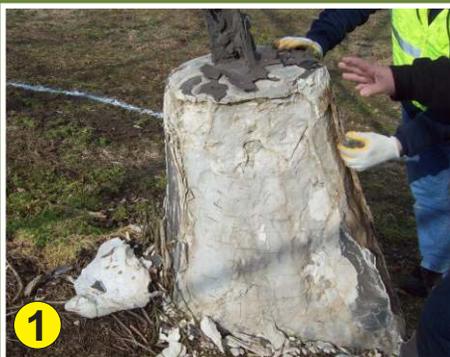
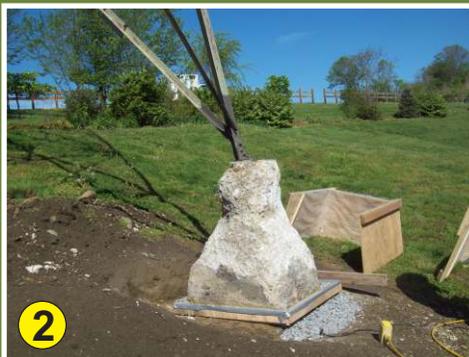
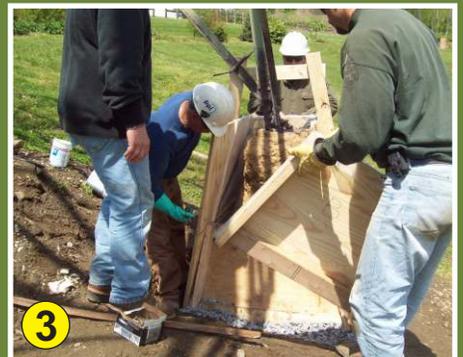
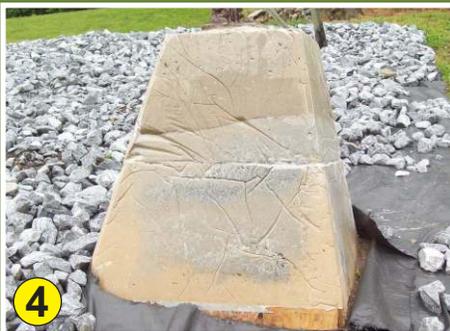
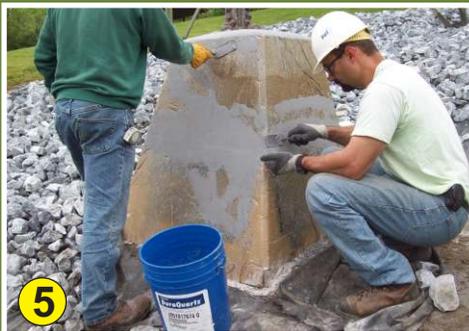
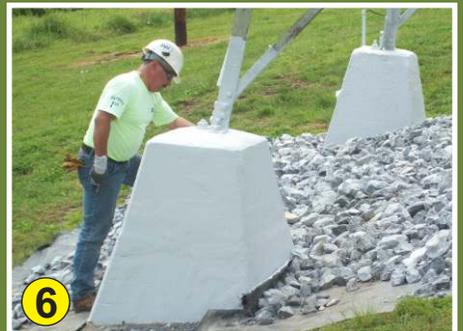
Problem: Electrical tower concrete base was crumbling due to exposure to the elements.

Solution: Loose concrete was manually removed and the base was enclosed with a wood former to re-build its shape. **ENECRETE DuraFill** was mixed with sand and pea gravel and then poured into the former.

After removing the wood former **ENECRETE DuraQuartz** was used to fill in any imperfections to provide a smooth surface to the base.

ENESEAL CR was then applied to prevent corrosion where the steel meets the base as well as to give a clean, uniform look to the structure.
