ENESEAL Improves Cooling Tower Efficiency While Adding Corrosion Protection at Meat Packing Plant

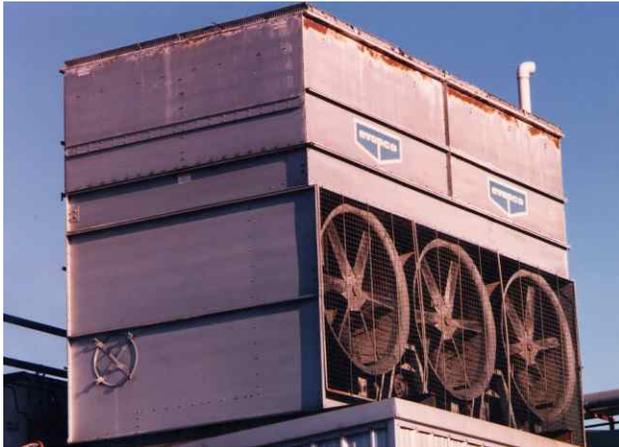
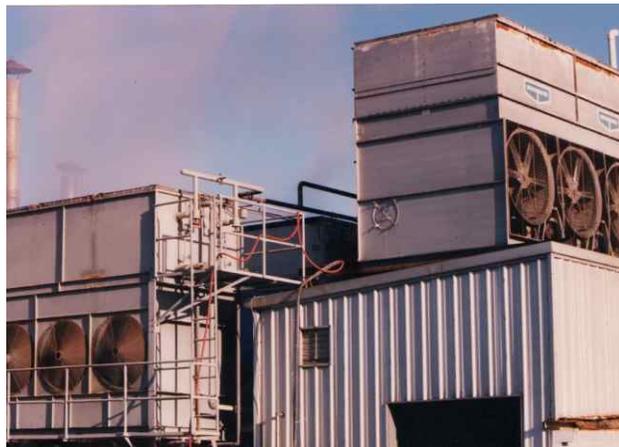
When these two cooling towers - part of the refrigeration system for this meat processing and packing plant in Virginia - needed refurbishing, the facility called in their local ENECON Fulid Flow Systems Specialist for advice.

The original galvanized metal on the units, both measuring 8 feet by 1 foot and standing 15 feet high, had weathered over the years and had become very dull - resulting in efficiency losses to the system. In addition, there was some localized corrosion damage along the top edges due to a fine mist always present in this area.

The units were first blasted, removing all rust down to bare metal. After priming these areas, two coats of the ENESEAL HR were applied using 45:1 Bulldog Airless Spray equipment.

The units were coated during a warm period of the fall with daytime temperatures around 80° (27° C). As the coating of different sections was completed, the plant engineers were amazed at the appreciable temperature difference they could feel with their bare hands between untreated sections and the areas already coated with the ENESEAL HR.
