CHEMCLAD & ENESEAL Save Large Water Tank at Chilean Dairy Product Manufacturer

Client:
Dairy Product Manufacturer

Location:
Chile

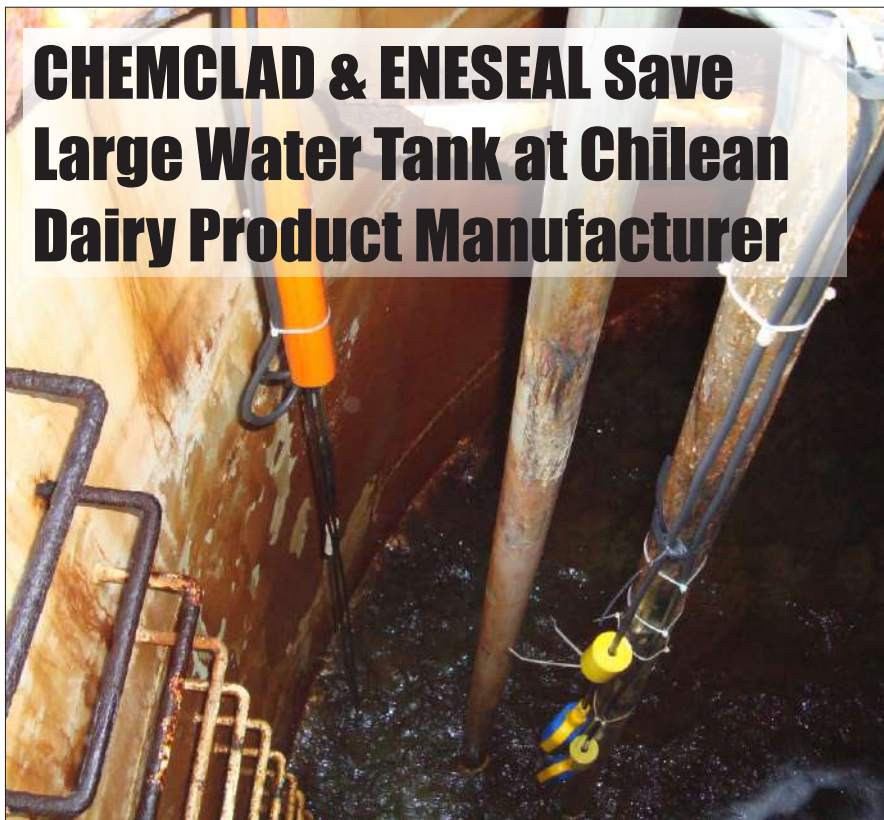
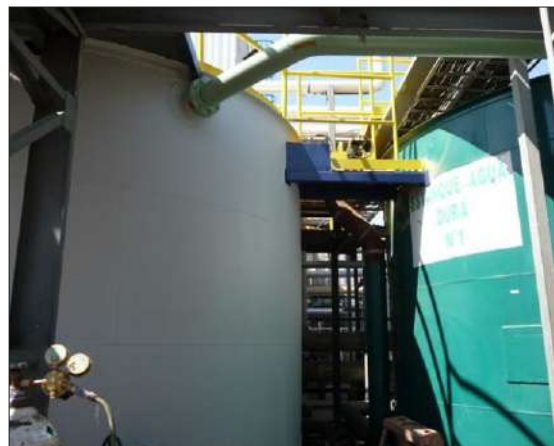
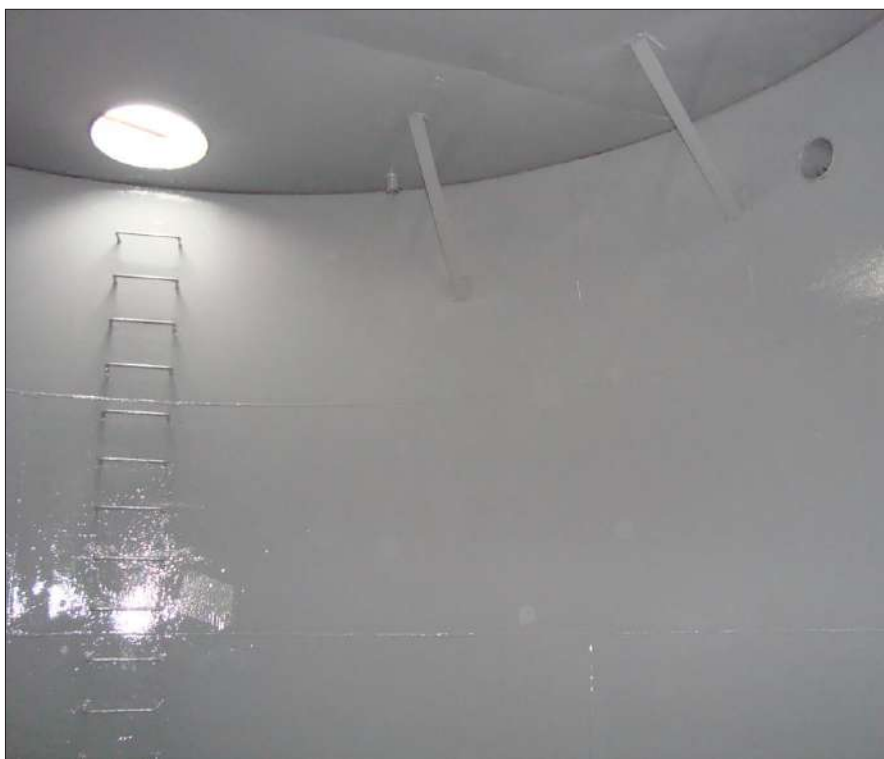
Problem:
Large hard water tank suffering from interior and exterior corrosion.

Solution:
The interior of the tank was grit blasted to a white metal finish then protected with 2 coats of CHEMCLAD GP. After mechanically cleaning and power washing, the exterior of the tank was protected with 2 coats of ENESEAL CR.
