A hydroelectric plant in British Columbia, Canada, has found the use of our ENECON FLEXICLAD DuraTough to be the best method of repairing and protecting these Francis Turbine Runners from severe cavitation attack.

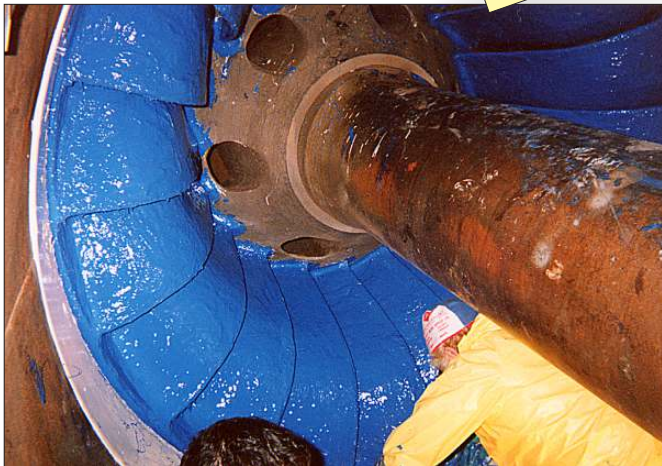
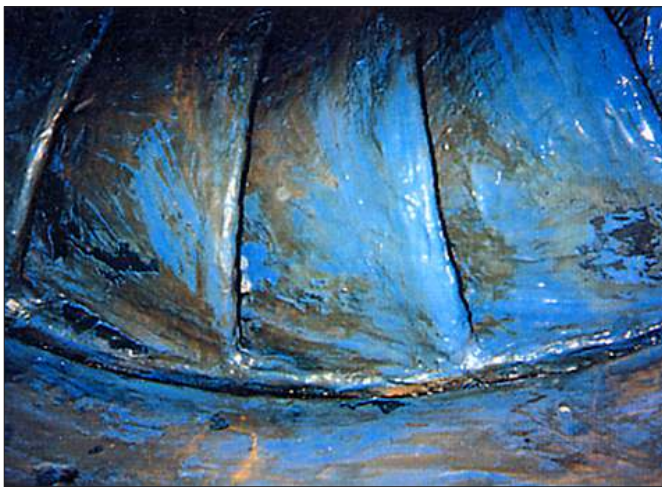
The units were repaired by first using CeramAlloy CP+ to rebuild the deeply damaged areas back to the original surface contour. This was followed by the application of two coats of the FLEXICLAD DuraTough DL system to completely resurface the runners.

After 12 months of continuous service, the

runner was inspected to determine the in-service performance capabilities of the DuraTough system.

The repair, and the DuraTough DL, had performed beyond expectations.
