\$300,000 Repair Project Completed at Major Northeastern Utility. 40-Year Old Cast Iron Water Boxes & Tube Sheets Repaired & Protected With CeramAlloy.

ENECON North East's Engineering Team, headed by Bob Barr and assisted by John Huber, completed a very difficult repair project at a fossil fuel power plant in the Northeast.

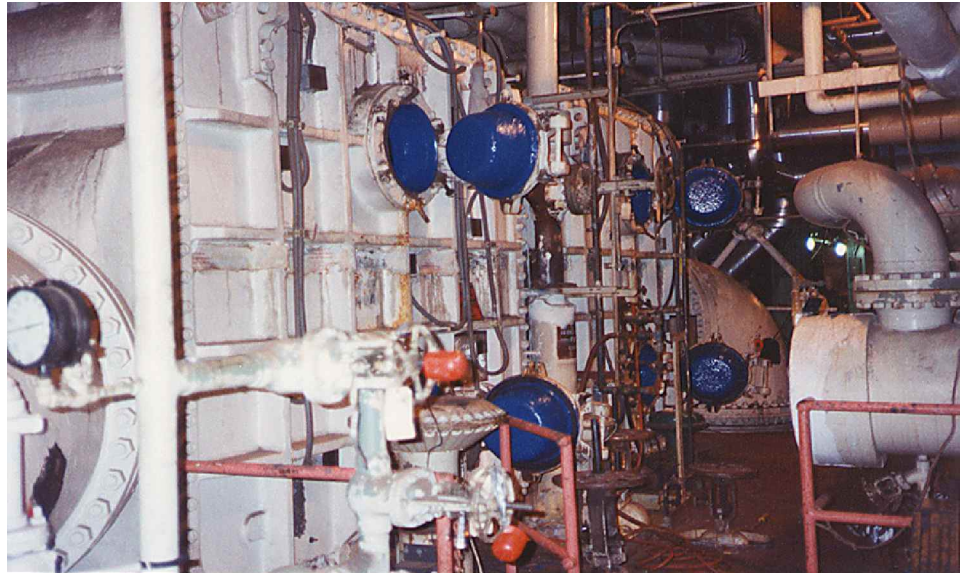
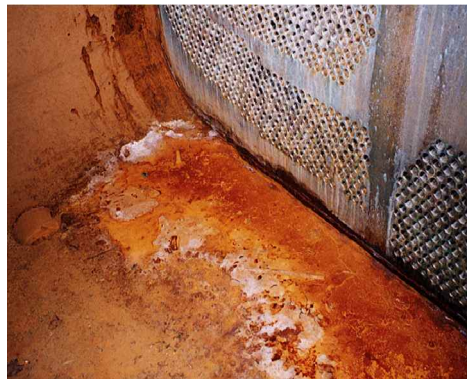
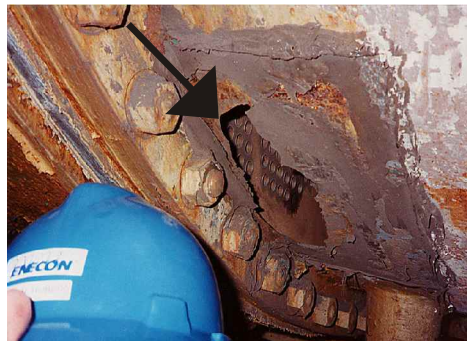
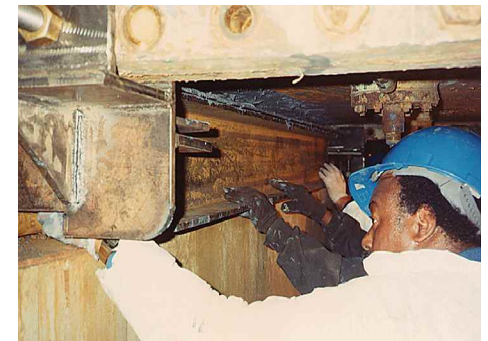
A total of 8 cast iron water boxes which were built in the 1950's plus 8 tube sheets were repaired, rebuilt and resurfaced with **ENECON CeramAlloy**

The cast iron water boxes were so severely damaged that huge holes, exposed during grit blasting, had to be repaired using steel plates and girders bonded and sealed with CeramAlloy.
