The Greek Navy Selects CeramAlloy & DurAlloy to Help Solve Some Very Difficult Repair Problems on Their Ships & Submarines

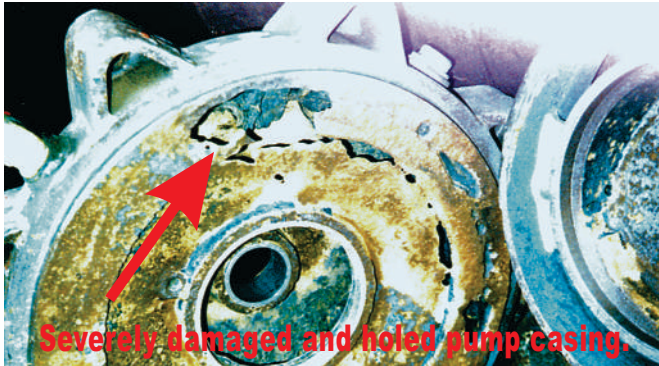
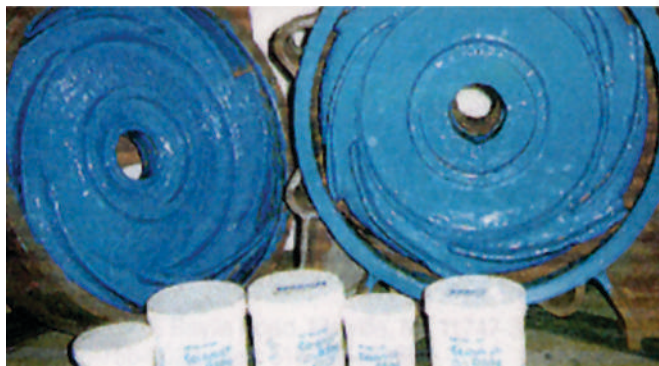
These fire pumps were completely destroyed by erosion and corrosion. METALCLAD CeramAlloy was used to rebuild and

resurface the pumps so that they can provide many more years of service to the Greek Navy.

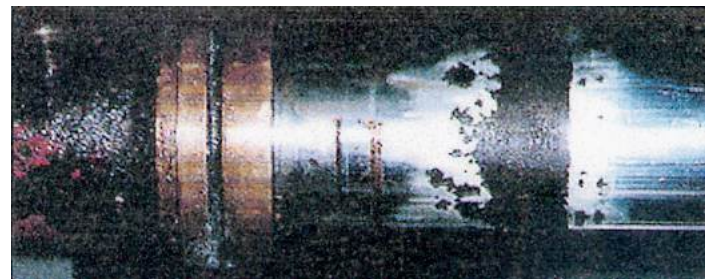
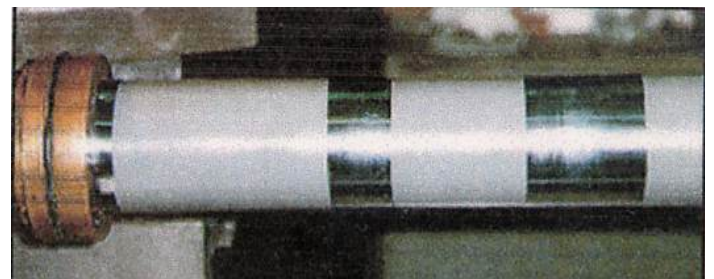
The second example highlights a repair to a damaged periscope piston from a Navy submarine. METALCLAD DurAlloy was used to rebuild the damaged areas saving the Navy a great deal of time and money when compared to conventional

welding or flame spraying repairs.

Of course, since DurAlloy requires **NO HEAT**, the danger of

warping the piston or creating metallurgical damage associated with welding was eliminated.
