## CeramAlloy Helps Salvage These Sewage Discharge Pipes at Main Pumping Station of a Major U.S. City

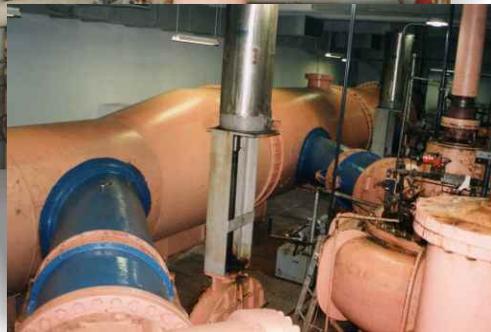
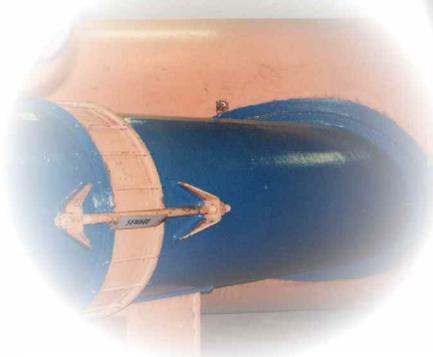
The ENECON North East Engineering Team was given a daunting challenge: to salvage this main pumping station's discharge pipes which were developing leaks due to the aggressive effluent as well as the age of the pipes, themselves.

The pipes were grit blasted and any leaks repaired with SpeedAlloy and DurAlloy. They were then 'wrapped' with CeramAlloy CL+ and fiberglass reinforcement tape to build up the wall thickness of the pipes. All the work was completed while the plant was fully operational. This project cost the plant a little over \$100,000, a small fraction of the million plus dollars which would have been needed to replace the pipes.
