ENECON Italia

Saves 90-Year Old Pump For The Italian Navy

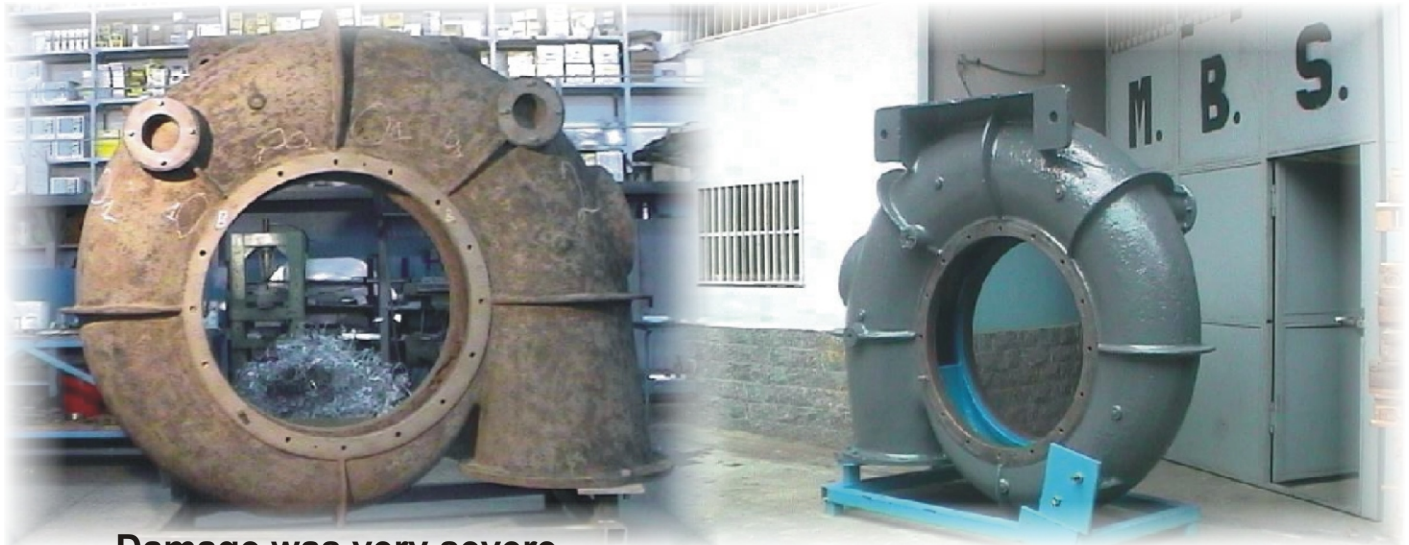
This huge, 90-year old, cast iron pump casing and impeller from an Italian Navy dry-dock were so severely eroded and corroded that the facilities engineers had decided to scrap it and order a new pump. The \$100,000 price tag for a new pump, however, persuaded the engineers to have the components rebuilt with ENECON High Performance Polymer Composite materials by the skilled engineering team at ENECON Italia.

The deeply pitted casing was first grit blasted then "primed" with CHEMCLAD SC. The

very deep pits were rebuilt with DuraQuartz and the entire surface coated with two coats of CeramAlloy CL+ [AC]. The outside of the casing was also protected with two coats of CHEMCLAD SC.

The damaged impeller was rebuilt with DurAlloy and then protected from future erosion and corrosion damage with two coats of CeramAlloy CL+ [AC].

The entire project was carried out at ENECON Italia's workshop in Naples at less than 10% of the replacement cost for a new pump.

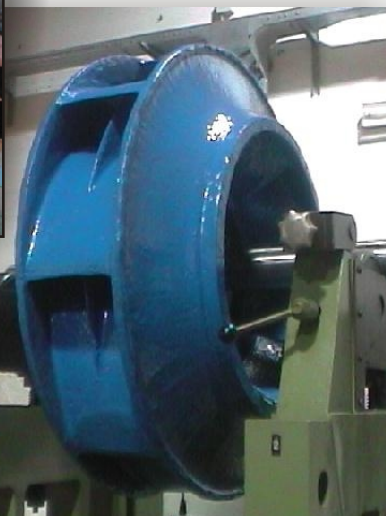
Damage was very severe
