Power Plant Repairs Manhole Access Covers On Main Cooling Water Intake Lines With CeramAlloy, CHEMCLAD And Some "Imagineering".

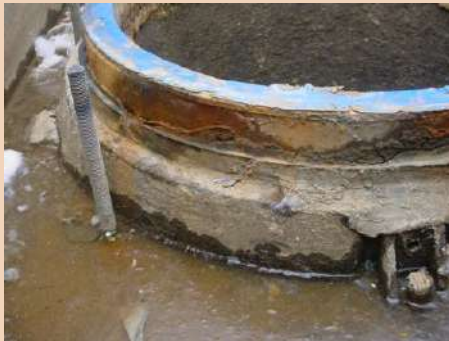
These two concrete manhole covers over the power station's main cooling water intake lines were in very poor condition. It was impossible to keep these sealed. So much water was leaking through the covers that sump pumps had to be used constantly in order to keep the pit from filling up with water.

New steel necks – larger than the O.D of the concrete flanges – will be fabricated. The new steel necks will slip over the existing concrete flanges and will be bonded to the concrete using ENECON CeramAlloy CP+AC. The CP+AC will be used to fill in the areas around the neck insuring a complete bond and seal to both the steel and the concrete...

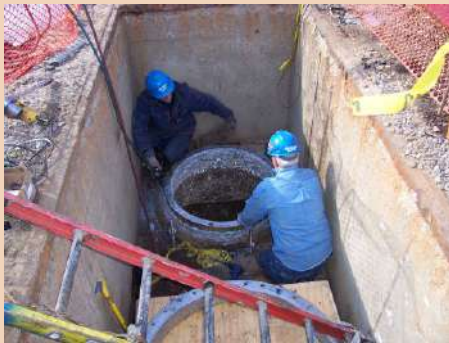
"The concrete areas where the manhole covers and the pipes meet are in very poor condition.

The concrete surfaces will be abrasive blasted to create a suitable anchor profile for bonding. All steel surfaces will be grit-blasted to an SSPC SP-10 (near white metal) finish with a 2 - 3 mil profile. All prepared metal and concrete surfaces will receive a final two-coat layer of ENECON CHEMCLAD GP..."
