U.S. Navy Saves \$37,000 On Emergency Heat Exchanger Repairs

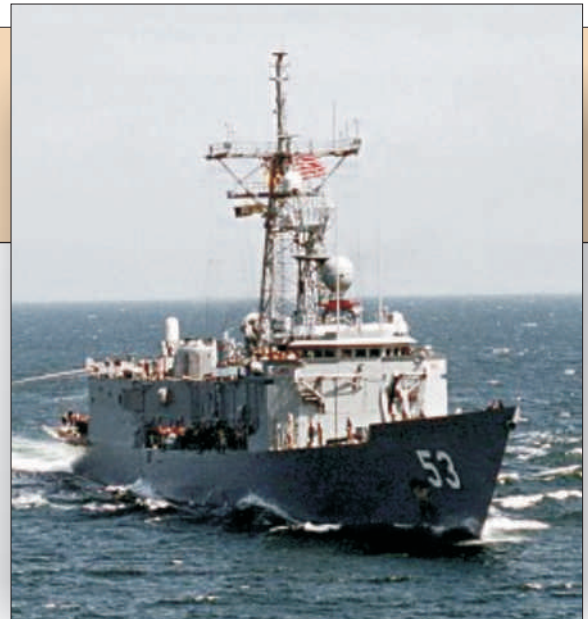
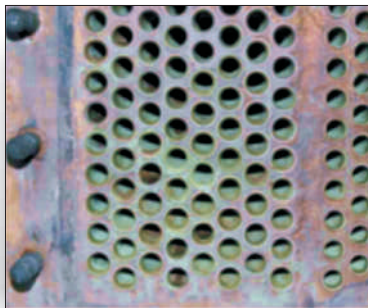
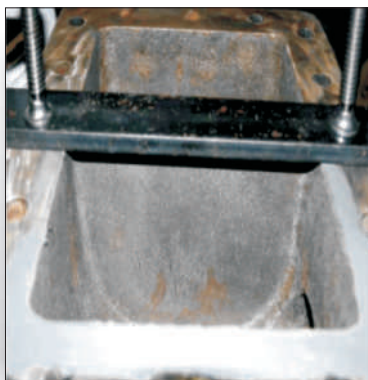
The engineers on this Navy Frigate recently discovered that one of the bleed air heat exchangers was suffering from such severe erosion/corrosion damage that the unit was not cooling sufficiently.

After the unit was grit-blasted, a 3 coat system of CeramAlloy CL+ was applied as illustrated in these photos. This entire project cost the Navy less than \$5,000.
