After 4+ Years Of Service In An Alumina Refinery, CeramAlloy CBX Is Still In Excellent Condition

Australian Alumina Refinery

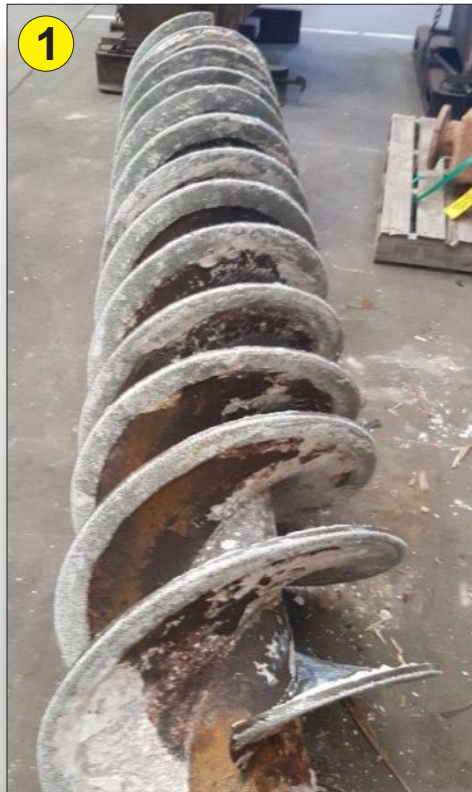
This screw (image 1) was protected with CeramAlloy CBX and put back into service for over 4 years.

After 4+ years in service.

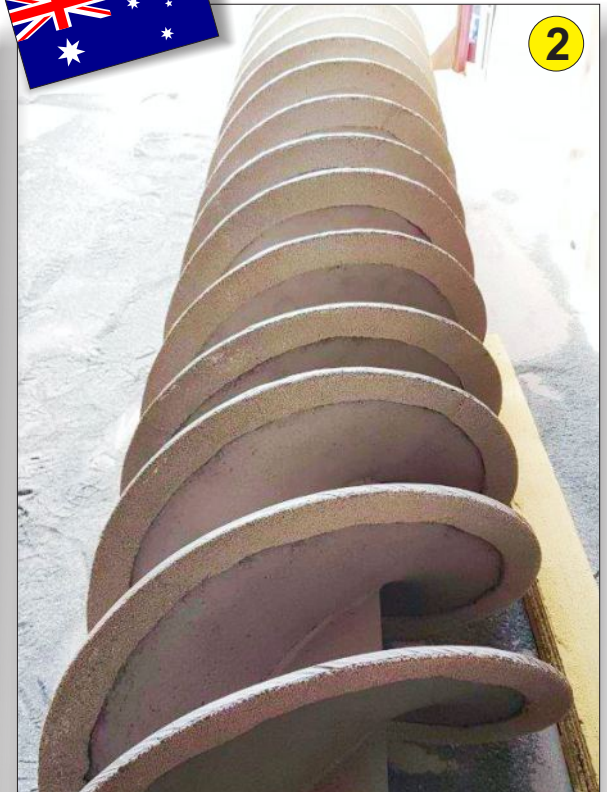
After brush blasting clean, the CeramAlloy CBX is shown to still be in excellent condition (image 2).

After cleaning, the CBX is still in excellent condition.
