Pump Repair Shop Uses CeramAlloy & DurAlloy To Repair & Protect Split-Case Pump

A chemical plant in Texas uses this split case pump to move water with entrained solids.

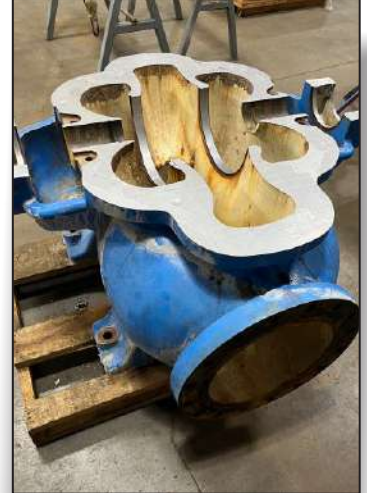
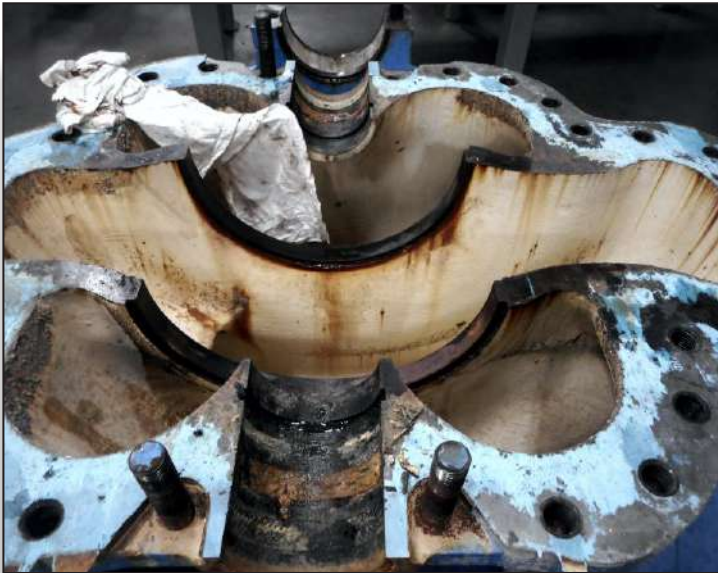
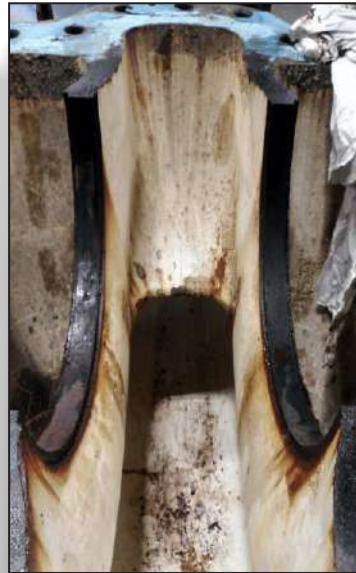
The pump was removed from service and taken to a local pump repair shop for regular erosion and corrosion damage

maintenance and repairs.

After protecting the flange face with tape, the inside of the pump was grit blasted and minor repairs were made with *METALCLAD DurAlloy*.

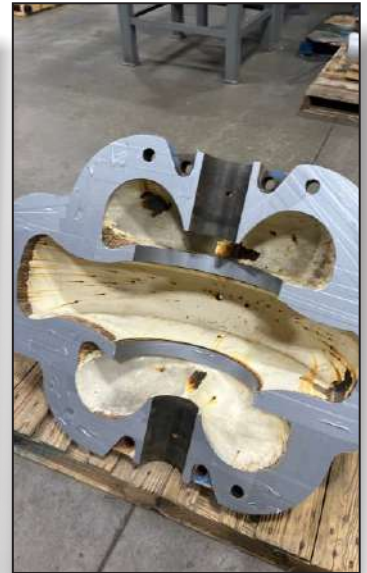
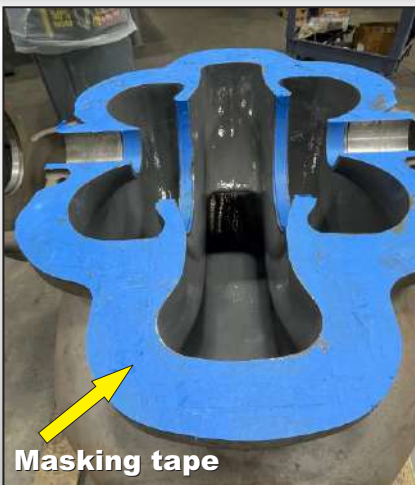
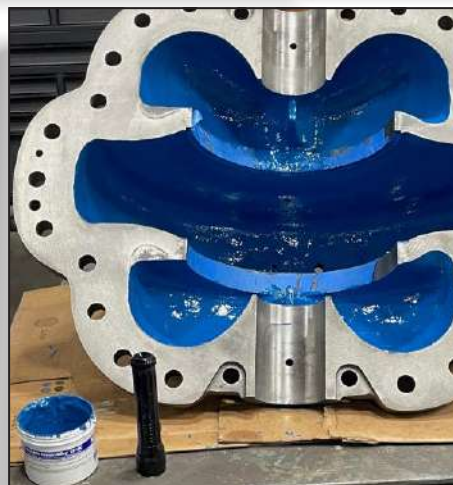
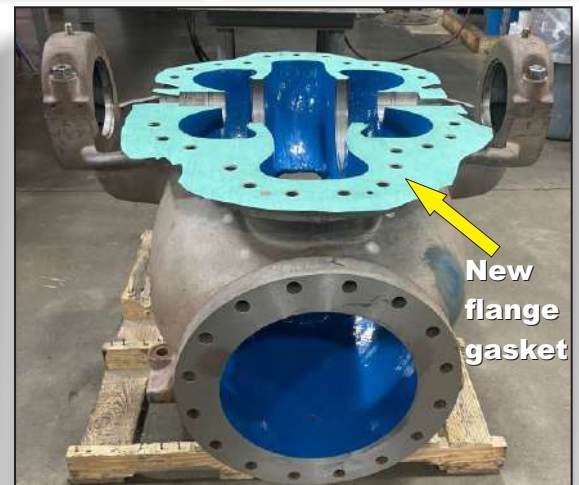
Two coats of *CeramAlloy*

CL+AC were then applied to the pump interior. The first coat in gray and the topcoat in blue.

A new flange gasket was installed and this pump went back into service with outstanding erosion and corrosion resistance.
